# **28F016SA/DD28F032SA SPECIFICATION UPDATE**

Release Date: July 1996

Order Number: 297408-006

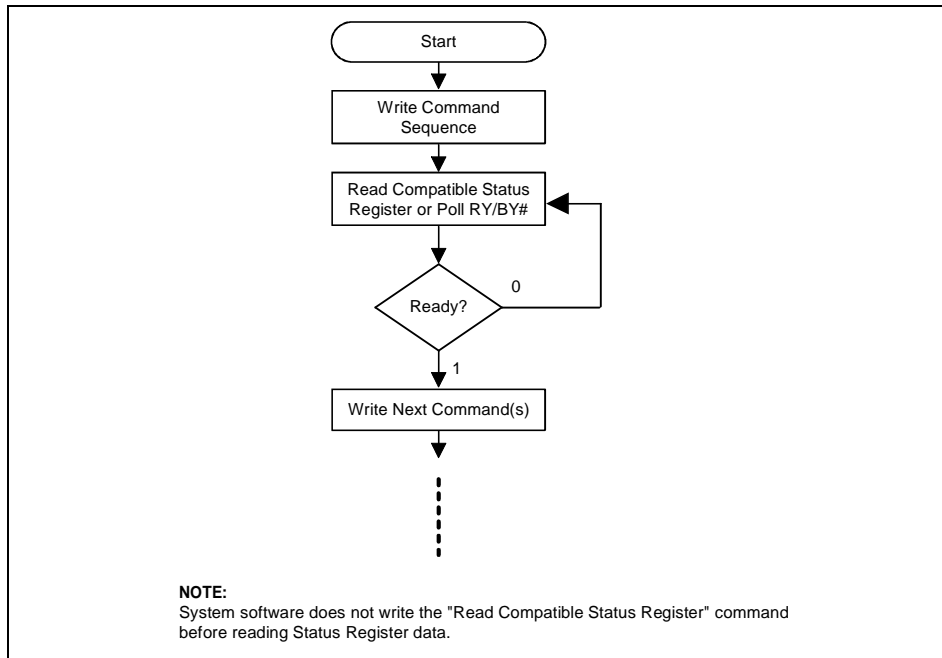
**Example System Software Flowchart That Will Not Encounter  
“Completion with Command Error or Invalid Device Operation” Condition**

**PROBLEM:** Systems in which software, after initiating device automation via a queueable command sequence, writes another command(s) to the device before automation completes may initiate unintended device operations.

In addition, the unintended device operation can initiate inadvertent program or erase attempts to Block 0 in systems which use the Sequential/Single Load to Page Buffer Commands (74H and E0H, respectively). Data alteration can only occur if Block 0 is not locked and  $V_{PP}$  equals  $V_{PPH}$ .

**WORKAROUND:** The following options listed below outline possible corrective actions required to avoid this errata. (Note: Any one of the options will eliminate this errata.)

**Option 1: Polling for “Ready” Indication**

Systems that poll the RY/BY# pin or WSMS bit (CSR.7) for “Ready” indication before writing another command to the device will not encounter this errata. This is illustrated in the *Example System Software Flowchart, etc.* figure below, and in flowcharts 11-1 and 11-2 (without erase suspend) of the *16-Mbit Flash Product Family User’s Manual*.

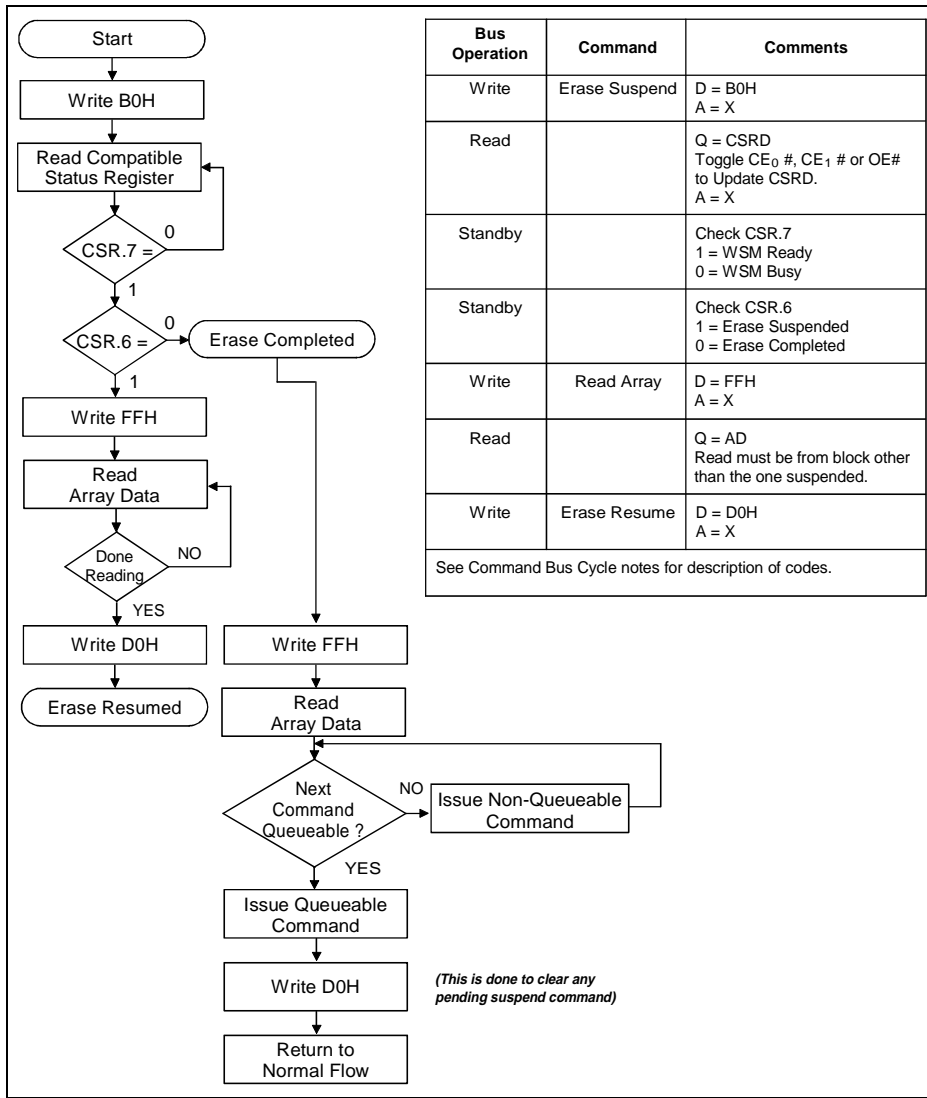
**Erase Suspend to Read Array with Compatible Status Register**

**PROBLEM:** If an Erase Suspend command is issued after completion of the Erase Cycle (either Single Block Erase or Erase All Unlocked Blocks) or too late in the Erase cycle, such that the Erase completes before the Status Register Suspend bit is set, the device will queue this unserviced Suspend request.

- A. If another Erase command is issued at some time later, the device then assumes that the pending Suspend request is still valid and will automatically Suspend the current Erase.
- B. If any queueable command is in the command queue waiting for execution while another queueable command is in progress, the Write State Machine will suspend its operation after completing the current command. (Refer to the *16-Mbit Flash Product Family User's Manual*, Section 11-1 for the queueable command list.)

**WORKAROUND:** Intel developed a software workaround to this errata, by inserting a second Resume command (DOH) following any queueable command in the Erase Suspend flowcharts. Both Erase Suspend to Read Array flowcharts (*16-Mbit Flash Product Family User's Manual*, Figures 11-3 and 11-12) detailing this workaround are attached to this errata (see the *Erase Suspend to Read Array with Compatible Status Register* and *Erase Suspend to Read Array with Extended Status Register* figures, which follow). This erratum results in the *Erase Suspend with Compatible Status Register* flowchart being incompatible with the 28F008SA *Erase Suspend* flowchart.
