28F016XS

SPECIFICATION UPDATE

Release Date: November 1996

Order Number 297553-007

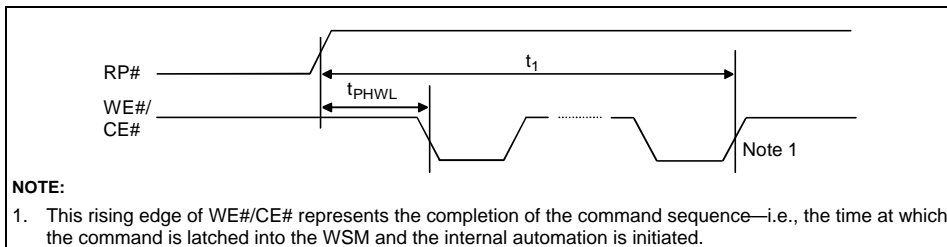
Operation Delay after Power-Up and Exit from Power-Down or Reset

PROBLEM: With the program/erase voltage (V_{PP}) at 5V, the internal V_{PP} detector may not stabilize for up to 5 μ s (illustrated by t_1 , in the figure below) after RP# transitions inactive (high). This causes an invalid V_{PP} Level bit indication when reading the Block Status Registers and termination of program, erase or lock block operations due to invalid device V_{PP} error detection. Affected operations include Word Write (40H/10H), Block Erase (20H) and Lock Block (77H).

IMPLICATION: The 5V V_{PP} power-up/reset time delay to first program or erase operation is impacted.

WORKAROUND: Upon reset, power-up, or wake-up from software sleep or hardware deep power-down, allow 5 μ s (t_1) before initiating a Write/Erase command (as listed earlier) or reading the V_{PP} Level bit of the Block Status Registers (BSR.1). The figure, *Operation Delay after Power-Up and Exit from Power-Down or Reset*, illustrates this timing requirement (t_1) in more detail.

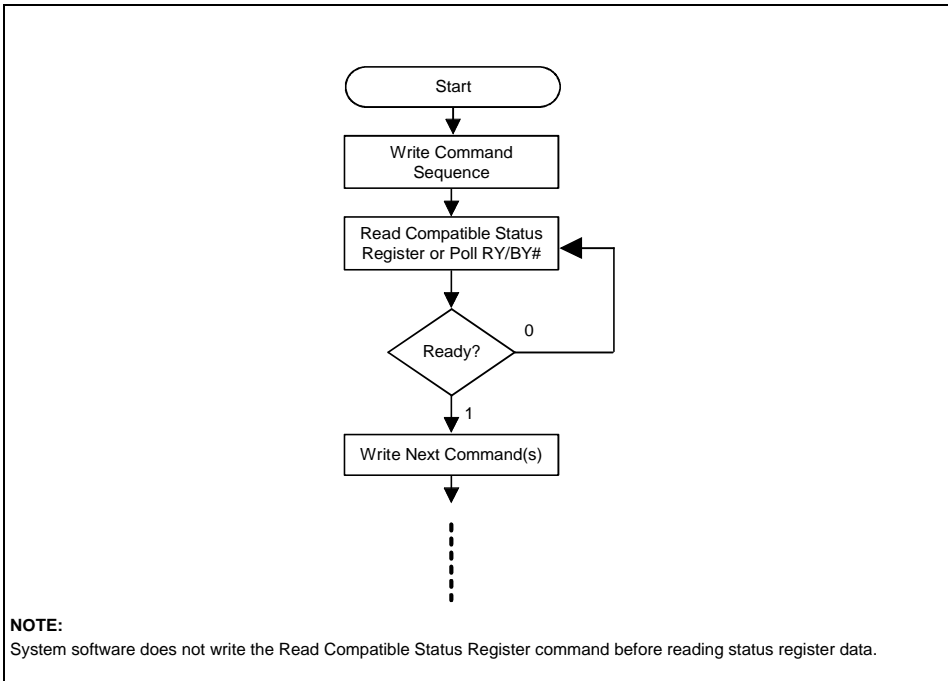
**Example System Software Flowchart That Will Not Encounter
“Completion with Command Error” Condition**

PROBLEM: Systems in which software, after initiating device automation, writes another command(s) to the device before automation completes may initiate unintended device operations.

Option 1: Polling for “Ready” Indication

Systems that poll the RY/BY# pin or WSMS bit (CSR.7) for “Ready” indication before writing another command to the device will not encounter this erratum. This is illustrated in the *Example System Software Flowchart*, etc. figure below, and in flowcharts 11-1 and 11-2 (without erase suspend) of the *16-Mbit Flash Memory Product Family User’s Manual*.

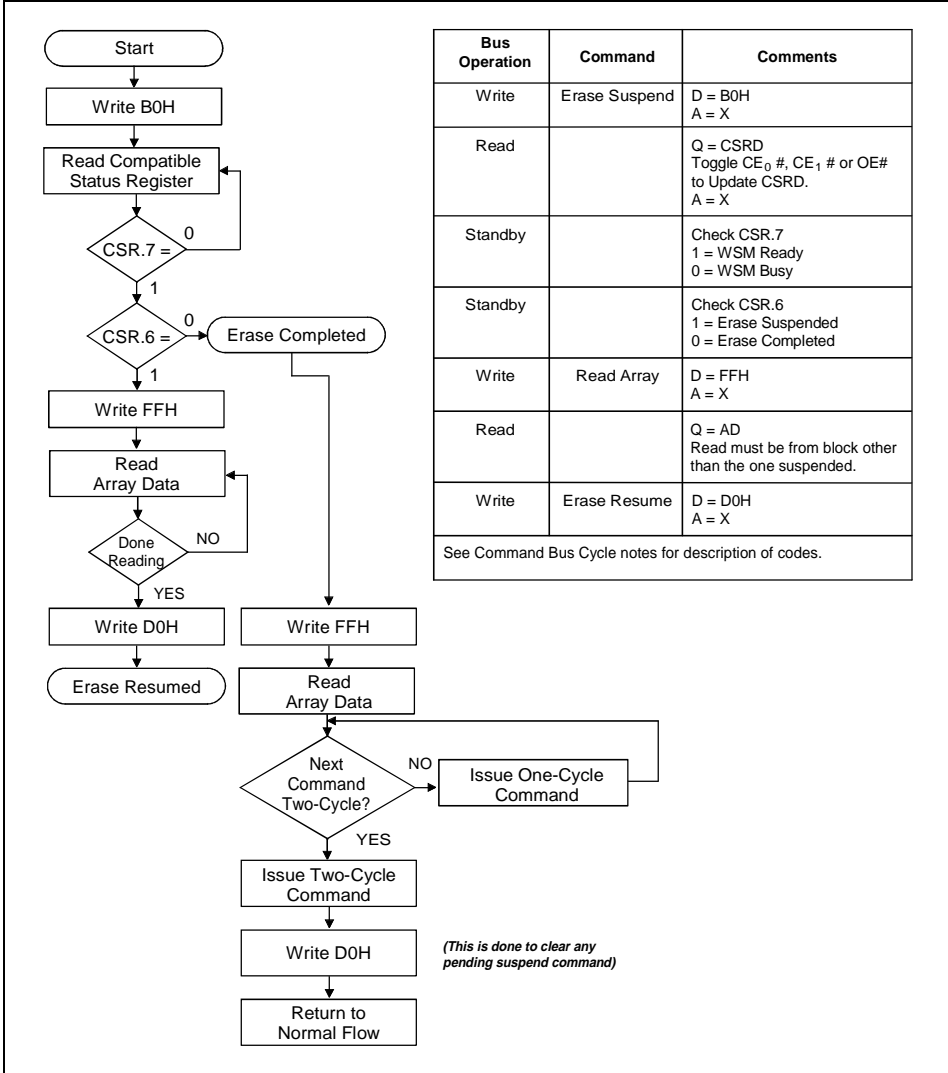
Erase Suspend to Read Array with Compatible Status Register

PROBLEM: If an Erase Suspend command is issued late in the Erase algorithm, it will not be recognized by 28F016XS components listed in the Affected Devices section, and erase will complete. This Erase Suspend command will **not** be discarded.

WORKAROUND: A software workaround to this erratum inserts a redundant Resume command (D0H) immediately following any Two-Cycle Command (Word Write, Block Erase, Lock Block, or Upload Status Bits) in the Erase Suspend flowcharts. Modified Erase Suspend to Read Array flowcharts (Figures 11-3 and 11-12 of the *16-Mbit Flash Memory Product Family User's Manual*) detailing this workaround are shown in the *Erase Suspend to Read Array with Compatible Status Register* and *Erase Suspend to Read Array with Extended Status Register* figures, which follow. This erratum results in the *Erase Suspend with Compatible Status Register* flowchart being incompatible with the 28F008SA *Erase Suspend* flowchart.

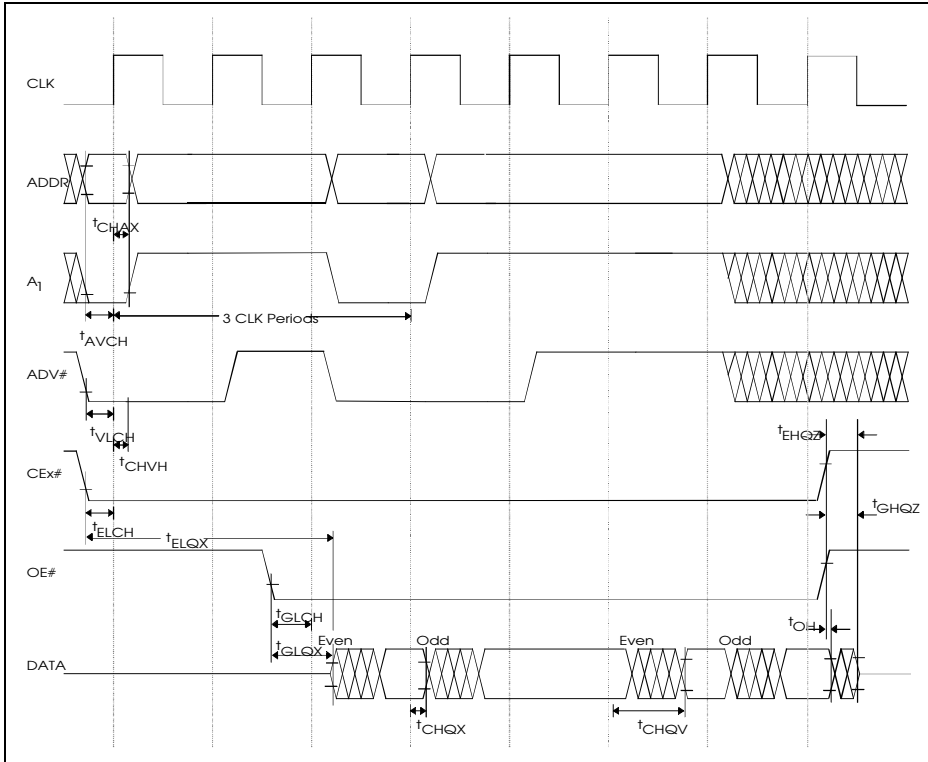
Read Timing Waveform (SFI Configuration = 2, Alternate-Bank Access)

The Read Timing Waveform, which follows, illustrates a modified version of the read timing waveform, Figure 11 in the *28F016XS 16-Mbit (1 Mbit x 16, 2 Mbit x 8) Synchronous Flash Memory Datasheet*, which illustrates this burst access sequence described in the previous paragraph. Similarly, this condition applies to all SFI Configurations.
