28F016SV

SPECIFICATION UPDATE

Release Date: May 1997

Order Number 297554-011

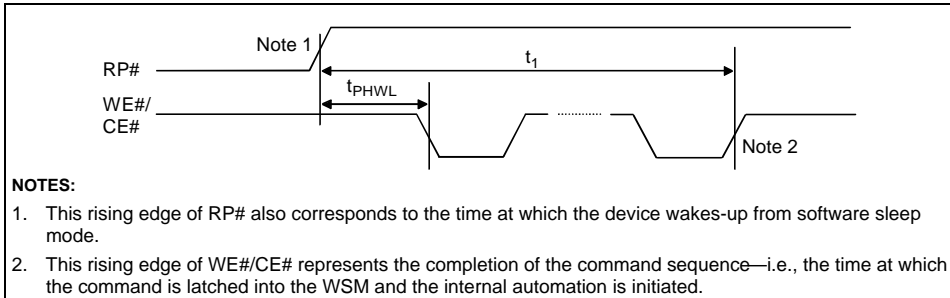
Queueable Operation Delay after Power-Up and Exit from Sleep, Power-Down, or Reset

PROBLEM: With the program/erase voltage (V_{PP}) at 5V, the internal V_{PP} detector may not stabilize for up to 5 μ s (illustrated by t_1 in the figure, *Queueable Operation Delay after Power-Up and Exit from Sleep, Power-Down, or Reset*, which follows) after RP# transitions inactive (high). This causes an invalid V_{PP} Level bit indication when reading the Block Status Registers and termination of program, erase or lock block operations due to invalid device V_{PP} error detection. Affected operations include Word/Byte Write (40H/10H), Single Block Erase (20H), Erase All Unlocked Blocks (A7H), Two-Byte Write (FBH), Page Buffer Write to Flash (0CH), and Lock Block (77H).

WORKAROUND: Upon reset, power-up, or wake-up from software sleep or hardware deep power-down, allow 5 μ s (t_1) before initiating a Write/Erase command (as listed earlier) or reading the V_{PP} Level bit of the Block Status Registers (BSR.1). The figure below illustrates this timing requirement (t_1) in more detail.

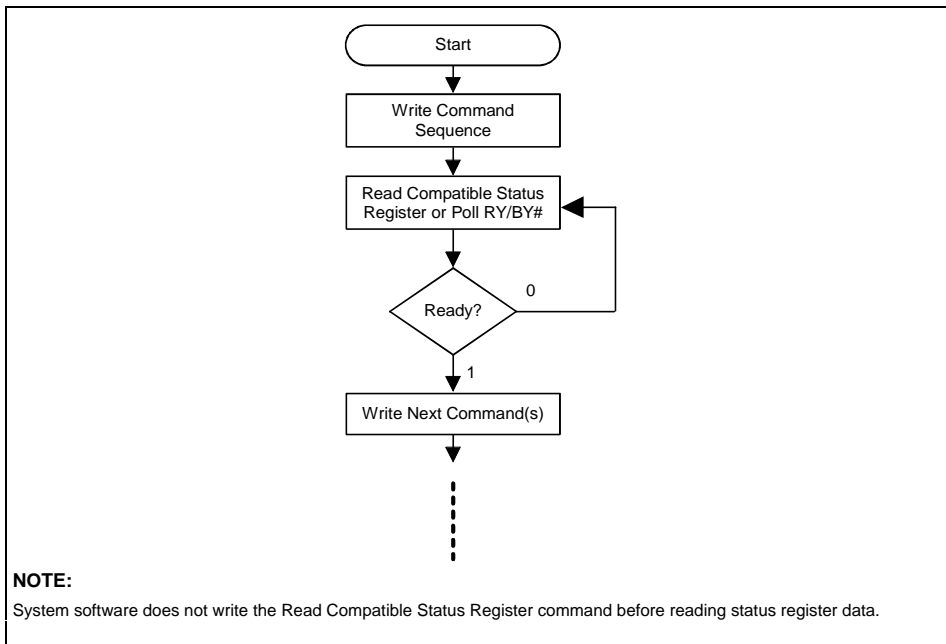
Example System Software Flowchart That Will Not Encounter “Completion with Command Error or Invalid Device Operation” Condition

PROBLEM: Systems in which software, after initiating device automation via a queueable command sequence, writes another command(s) to the device before automation completes may initiate unintended device operations.

Systems that poll the RY/BY# pin or WSMS bit (CSR.7) for “Ready” indication before writing another command to the device will not encounter this errata. This is illustrated in the *Example System Software Flowchart, etc.* figure below, and flowcharts 11-1 and 11-2 (without erase suspend) of the *16-Mbit Flash Product Family User’s Manual*.
