Intel[®] 815 Chipset Platform

Design Guide Update

January 2001

Document Number: 298250-002

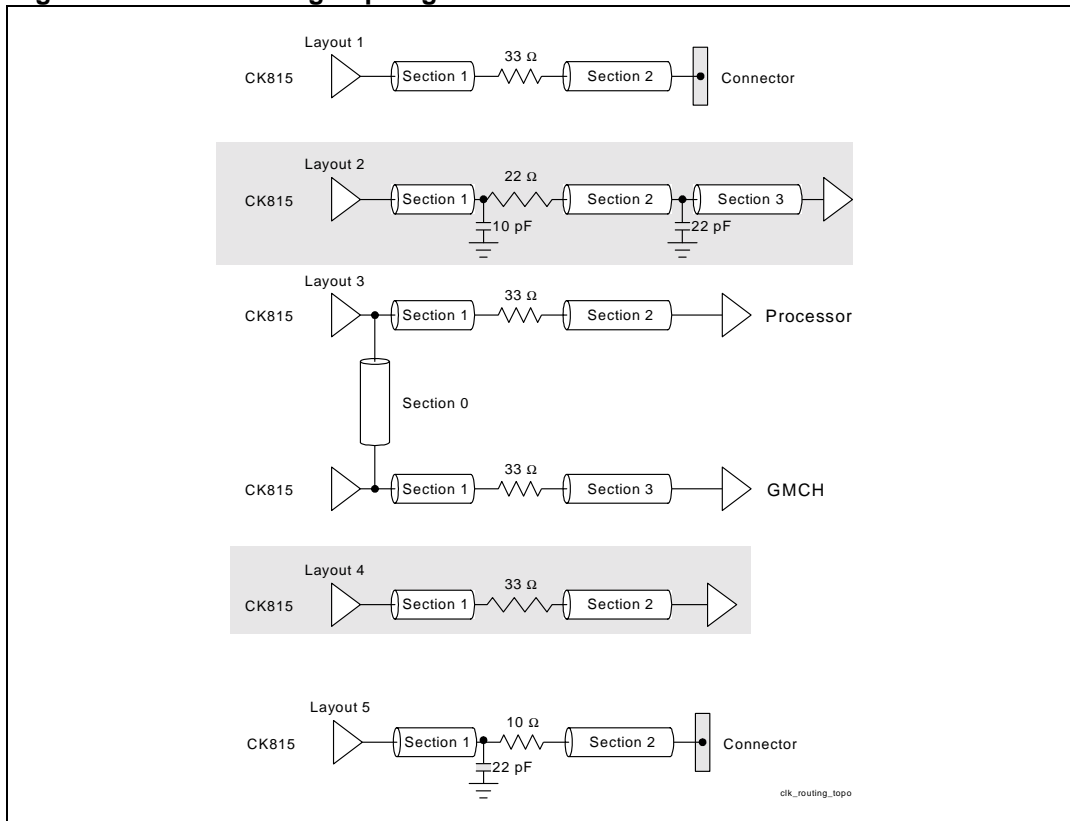
Figure 59. Clock Routing Topologies

This section presents the generic clock routing guidelines for both 2-DIMM and 3-DIMM boards. For 3-DIMM boards, additional analysis must be performed by the motherboard designer to ensure that the clocks generated by the external PCI clock buffer meet the PCI specifications for clock skew at the receiver, when compared with the PCI clock at the ICH.

Destination	Topology from Previous Figure	Section 0 Length	Section 1 Length	Section 2 Length	Section 3 Length
SDRAM MCLK	Layout 5	N/A	< 0.5"	A ¹	N/A
GMCH SCLK ³	Layout 2	N/A	< 0.5"=L1	A + 3.5" – L1	0.5"
Processor BCLK	Layout 3	< 0.1"	< 0.5"	A + 5.2"	A + 8"
GMCH HCLK			<0.5"		
GMCH HUBCLK	Layout 4	N/A	<0.5"	A + 8"	N/A
ICH HUBCLK	Layout 4	N/A	<0.5"	A + 8"	N/A
ICH PCICLK	Layout 4	N/A	<0.5"	A + 8"	N/A
AGP CLK	Layout 4	N/A	<0.5"	A + 3" to A + 4"	N/A
PCI down ²	Layout 4	N/A	<0.5"	A + 8.5" to A + 14"	N/A
PCI slot ²	Layout 1	N/A	<0.5"	A + 5" to A + 11"

1. Length "A" has been simulated up to 6".
2. All PCI clocks must be within 6" of the ICH PCICLK route length. Routing on PCI add-in cards must be included in this length. In the presented solution space, ICH PCICLK was considered to be the shortest in the 6" trace routing range, and other clocks were adjusted from there. The system designer may choose to alter the relationship of PCI device and slot clocks, as long as all PCI clock lengths are within 6". Note that the ICH PCICLK length is fixed to meet the skew requirements of ICH PCICLK to ICH HUBCLK
3. 22 pf Load cap should be placed 0.5" from GMCH Pin.

- All clocks should be routed 5 mils wide with 15-mil spacing to any other signals.
- It is recommended to place capacitor sites within 0.5" of the receiver of all clocks. They are useful in system debug and AC tuning.
- Series resistor for clock guidelines: 22 Ω for GMCH SCLK and 10 Ω for SDRAM clocks. All other clocks use 33 Ω .
- Each DIMM clock should be matched within ± 10 mils.
