Intel[®] 840 Chipset: 82840 Memory Controller Hub (MCH)

Specification Update

January 2001

Document Number: 290697-001

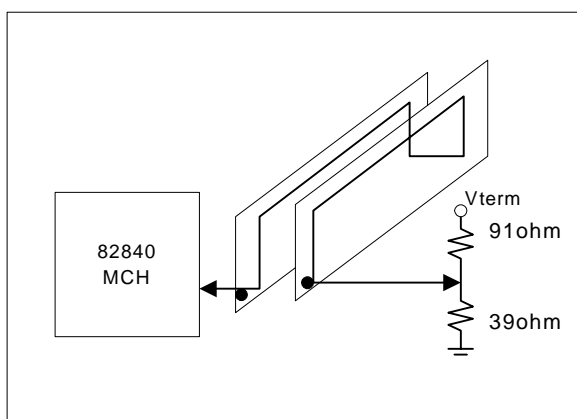
10. SCK Tri-States during STR

Problem: The MCH tri-states SCK during STR entry causing a “glitch” on SCK. This “glitch” results in a protocol violation to the RDRAM devices and the system will not resume.

Implication: The system will not resume from the S3.

Workaround: Instead of using 56 Ω /56 Ω , SCK and CMD should be terminated with 91 Ω pull-up resistor (to V_{term}) and 39 Ω pull-down resistor. **These termination values are applicable for all memory configurations including RIMM and MRH-R (expansion channel).**
