Intel[®] 815 Chipset Family: 82815 Graphics and Memory Controller Hub (GMCH)

Specification Update

May 2001

Document Number: 298253-003

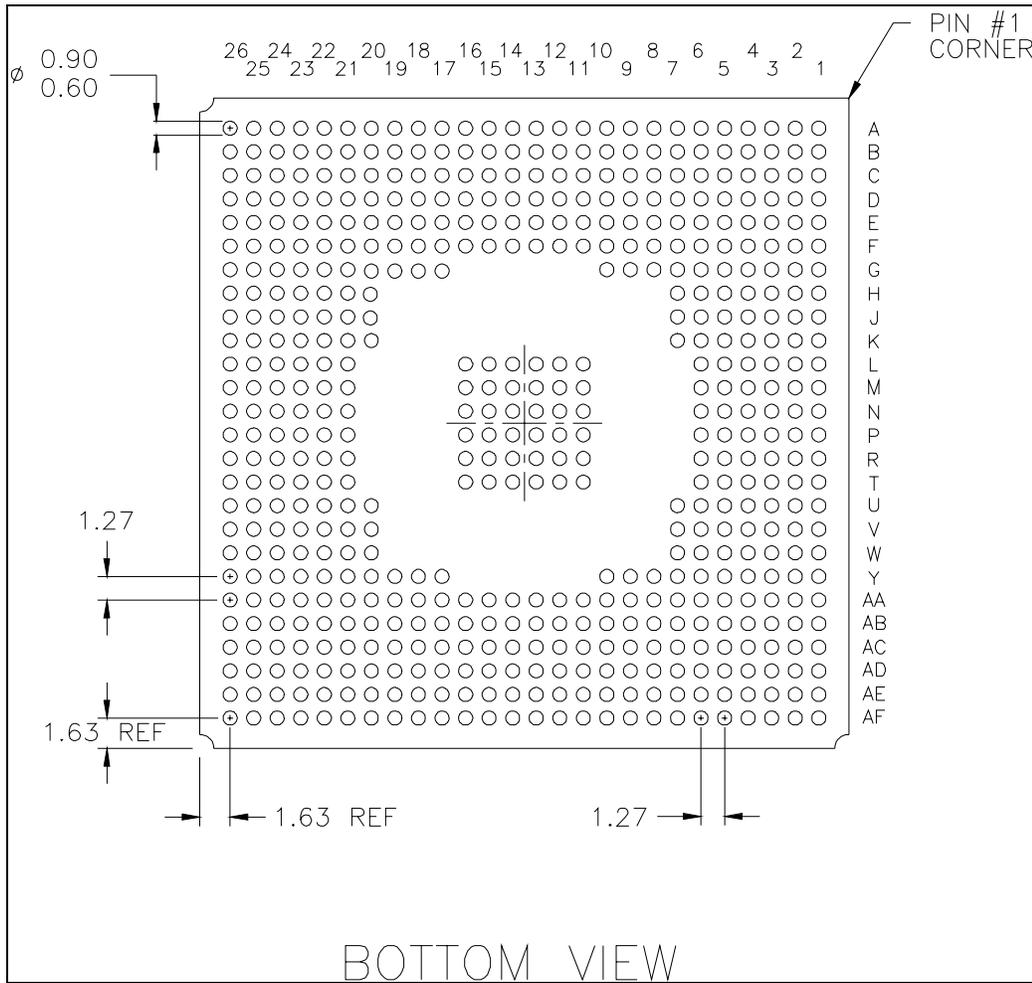
1. 82815 544 BGA Ball-Out Package Dimensions Is Corrected

Reference Section 5.2, *Package Information*, in the datasheet. Replace Figure 13 with the following correct 544 BGA ball-out bottom view:
