i960[®] VH Embedded-PCI Processor

Specification Update

August 2004

Order Number: **273174-011**

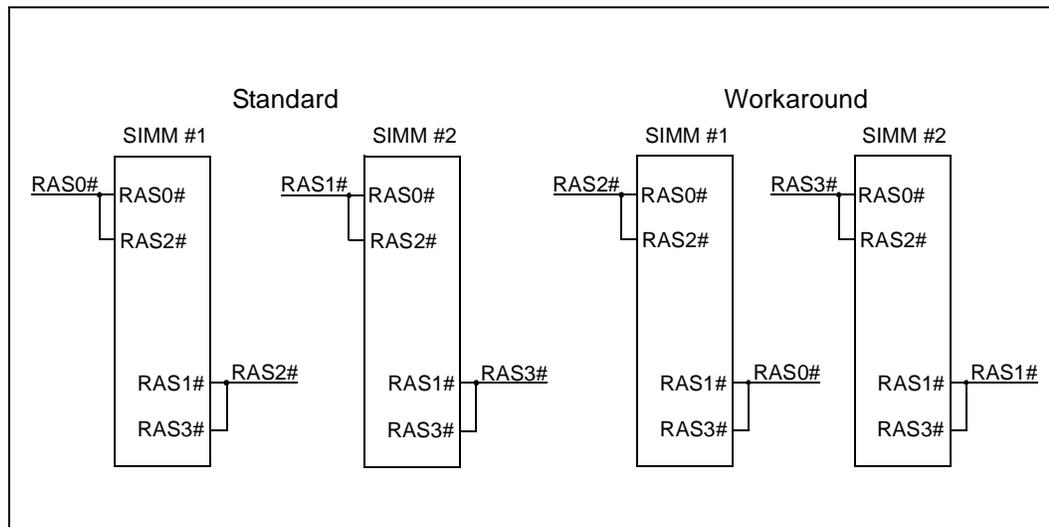
Figure 1. DRAM RAS# Configurations

When the 80960VH initializes from 80960 local memory instead of FLASH/ROM, the 80960VH's first instruction fetch of the IBR is hard-coded to address 0xFEFF FF30. When the MCU reads this address, it asserts RAS2# or RAS3#, depending on the DRAM bank/leaf size.

1. A read of the IBR is issued to 0xFEFF FF30.
2. Since 4-Mbytes is the DRAM bank/leaf size, the MCU decodes the next two higher order bits 23:22 from within the address to determine which RAS# signal to assert during the DRAM access.
3. IBR address bits 23:22 = 11₂, and the MCU asserts RAS3# (See [Table 1](#)).
4. RAS3# selects an unpopulated DRAM bank, the IBR will not be read, and the device will not initialize.

CASE 2 WORKAROUND - Initializing from 80960VH DRAM instead of FLASH/ROM

In a standard DRAM configuration, RAS0# and RAS1# are routed to the front sides of the SIMMs, and RAS2# and RAS3# are routed to the back sides of the SIMMs. To implement this workaround, swap RAS0# and RAS2# and swap RAS1# and RAS3#. This routes RAS2# and RAS3# to the front sides of their respective SIMMs, and routes RAS0# and RAS1# to the back sides of their respective SIMMs (See [Figure 1](#)). To determine which RAS# is asserted for a particular address and DRAM configuration, see [Table 1](#).

When initializing from 80960VH DRAM, the first instruction fetch of the IBR is hard-coded to address 0xFEFF FF30; as a result, A23:22 = 11₂ and RAS3# is asserted. With the workaround in place, the RAS# lines are swapped and RAS3# is connected to the front side of the second SIMM and the IBR can be read.
