82546EB Gigabit Ethernet Controller Specification Update

September 26, 2006

The *82546EB* Gigabit Ethernet Controller may contain design defects or errors known as errata that may cause the product to deviate from published specifications. Current characterized errata are documented in this Specification Update.

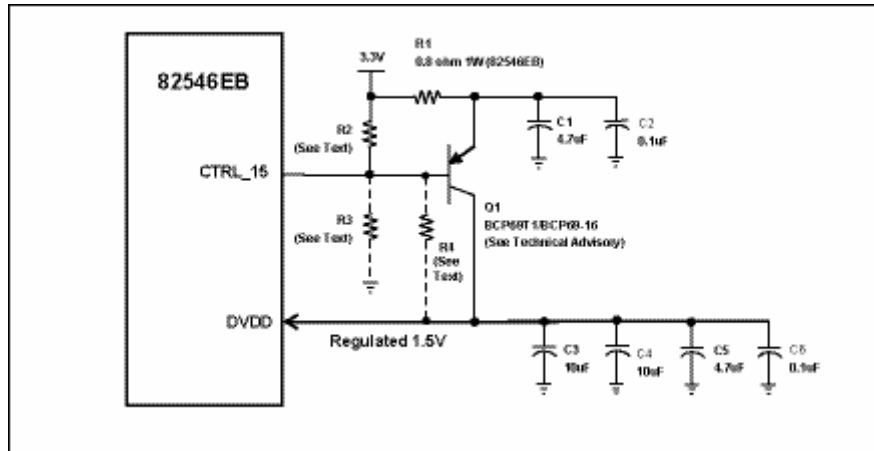
8. 1.5V Regulator Control Circuit Start Up

- Implication:** When drive is absent on the CTRL_15 output, only leakage current from the CTRL_15 output will be present. Depending on the amount of leakage current and the gain (Beta) of the external PNP transistor, there may be insufficient collector current ($I_C = I_B * \text{Beta}$) to adequately supply the 1.5V rail, and the 1.5V regulator circuit may not turn on. The 1.5V rail requires a minimum collector current of 5 mA to be generated and a 1.5V rail voltage of at least 600 mV to ensure that the digital portion of the circuit turns on correctly.

- When the 1.5V regulator control output fails, the 2.5V regulator control output(s) may also fail, driving the 2.5V supply toward either 0V or the 3.3V rail. The absence of one or both of the 1.5V and/or 2.5V supplies prevents the Ethernet controller from operating correctly.

- Due to variations in PNP minimum/maximum transistor gain, this circuit must adhere to specific requirements for the PNP transistor, R3 resistor value, and configuration of the 82546EB controller. Follow **workaround instructions** in Technical Advisory TA-149, "Possibility of 1.5 Voltage Regulator Failures on 82546EB LOM Designs." **Note:** Workarounds differ among the 82540EM and 82546EB controllers and each controller has a separate technical advisory.

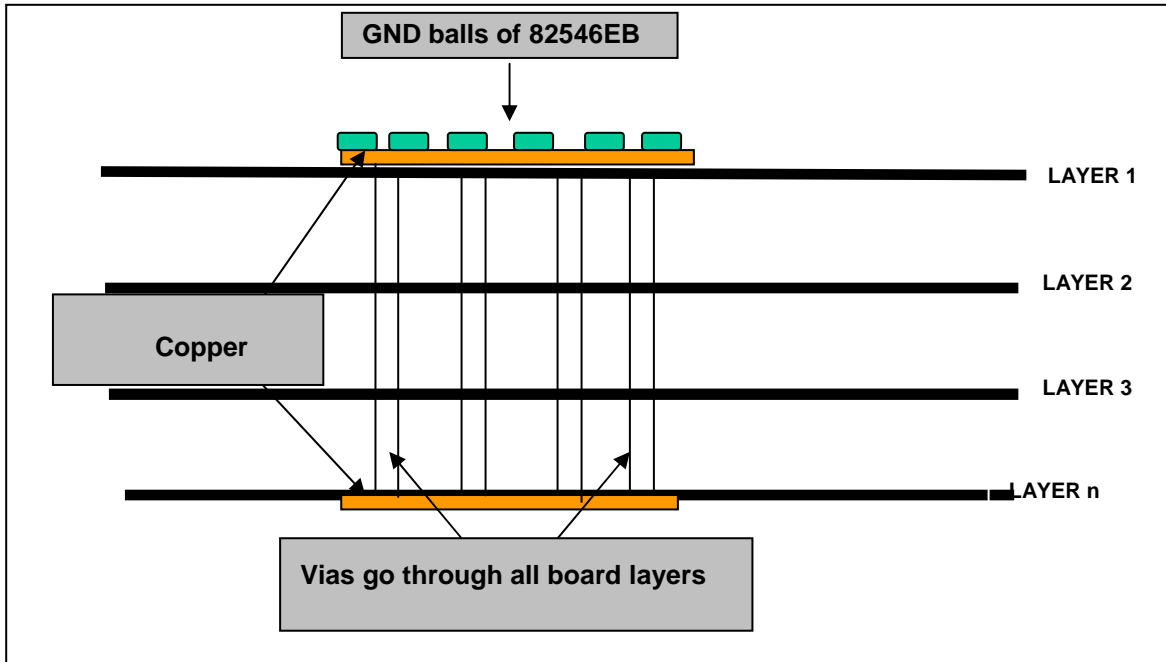
Following the above recommendations can dramatically reduce the case temperature of the 82546EB Gigabit Ethernet Controller, keeping the junction temperature within safe limits. In one experiment, using 2 oz. copper instead of 1 oz. copper on six layer circuit boards reduced the measured case temperature from approximately 87°C to 72 °C.
