# Monthly Specification Update

***Intel® Server Board S5000PAL***

***Intel® Server System SR1500AL***

*Intel Order Number D65289-035*

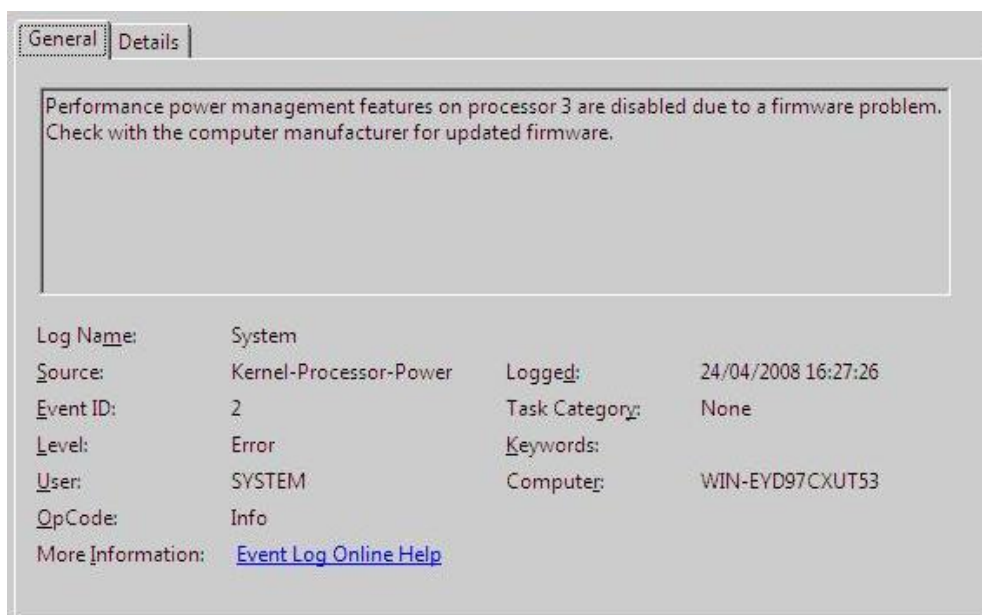
## 57. Performance Power Management Error in Microsoft Windows Server 2008\*

Problem	If you are use any Intel® Xeon® Processor of the 5300 or the 5400 series in the Intel® S5000PAL Server Board and install Microsoft Windows Server 2008* on the system, you may encounter the following error in the Windows* event log:
---------	---

The Event Error is related to a change in Microsoft's validation and logging of supported P-States for a processor. The wording of the error that is displayed is misleading. There is no performance impact. Microsoft logs the error because the BIOS has a default PSS object (P-State info) in the ACPI space for these processors. Basically, this default PSS object indicates no P-State is supported. However, Microsoft Windows Vista\* and Microsoft Windows Server 2008\* have changed their interpretation of this table.

Implication	BIOS version 88 or even an earlier version may produce this erratum.
-------------	--

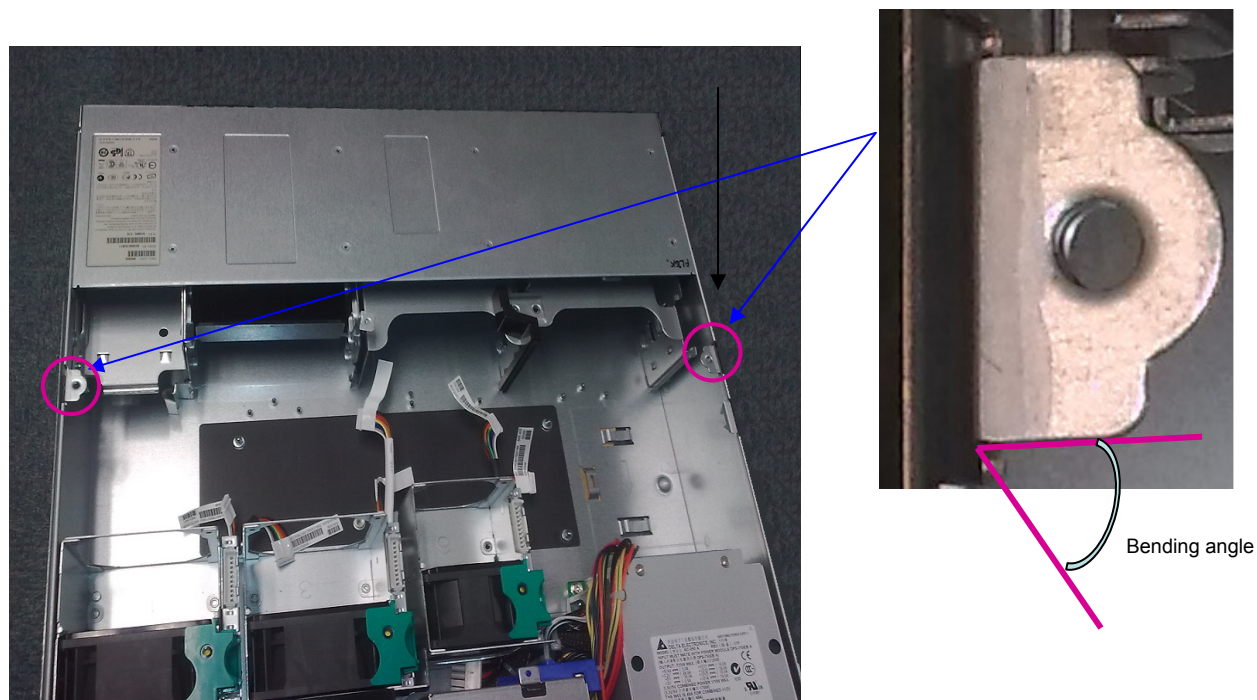
## 63. Hard Disks Are Difficult to Install in Intel® Server System SR2500AL and Intel® Server Chassis SR2500

Problem	Customers may find it difficult to properly and fully install the hard drives into the hard drive slots. This is because the backplane is about 0.5-1.5 mm vertically higher than the specification.
Status	This erratum has been fixed.
Workaround	Check to ensure the bottom of the backplane touches the chassis base. If there is an obvious gap, check the two bending features (shown below) and make sure the bending angle is no more than 90 degrees. If necessary, use flat-nose pliers to bend these two features down to lower the backplane. Contact your local Intel Customer Service for more information.

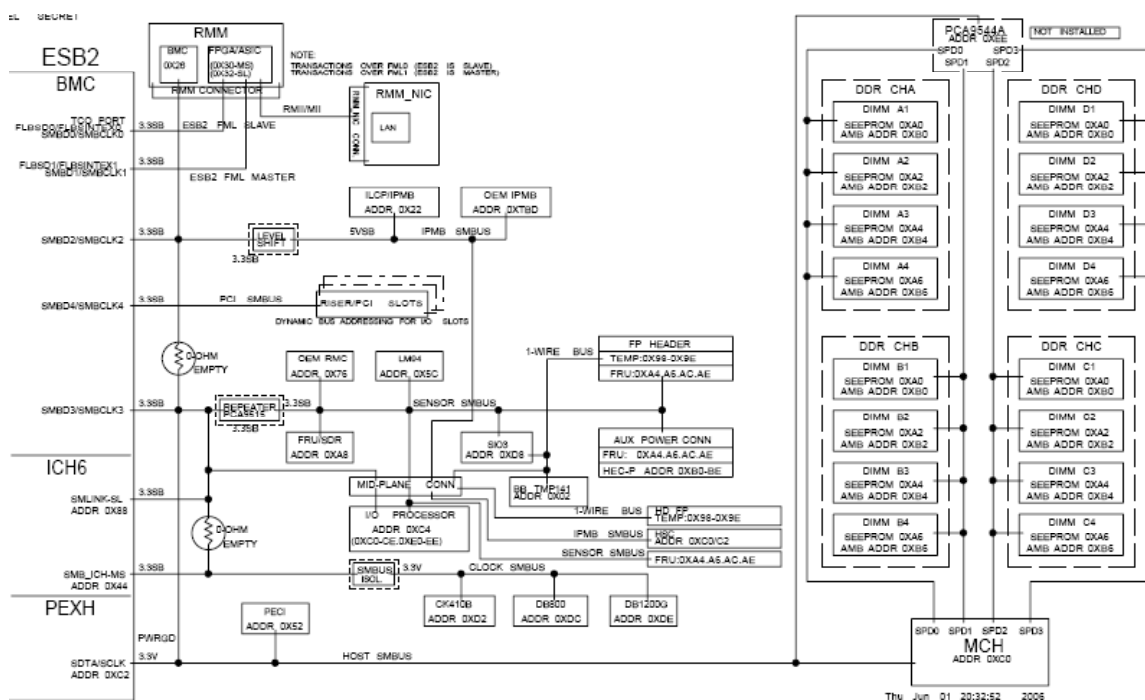
- Add PECI controller
- Remove separate HSC connector
- Correct Midplane -> FP SMBus connections and 1-wire temp sensor
- Correct SMBus and 1-wire temp sensor connections to FP connector
- Correct FBDIMM labeling

The corrected diagram is shown:

**Implication:** Inaccurate understanding of actual server board design with respect to the specified diagram.

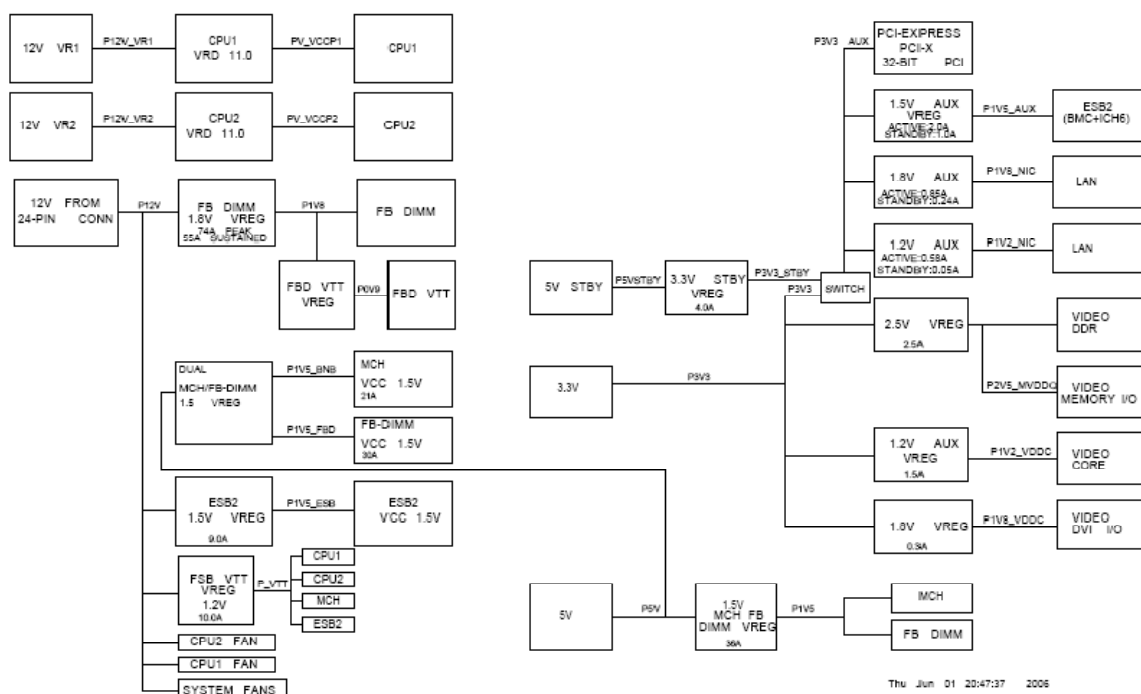
- MCH/FBDIMM 1.5 Vreg moved from 12 V rail to 5 V rail.
- Video Memory Vreg corrected to only one 2.5 V reg. instead of two.
- “ATI” label for Video components changed to generic “Video”.

The corrected diagram is shown:

**Implication:** Inaccurate understanding of actual server board design with respect to specified diagram.

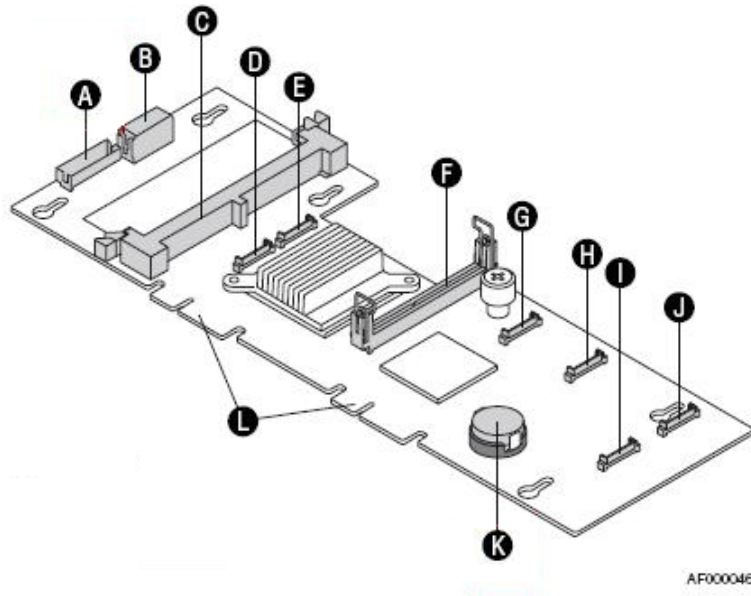
**Figure 22. SAS/SAS RAID Mid-plane Board**

The chassis also supports an active SAS / SAS RAID mid-plane. This system board incorporates an LSI\* LSISAS1068 SAS controller onto the board. See Chapter 5 for details describing SAS / SAS RAID support. The following diagram shows the location for each connector found on this board.

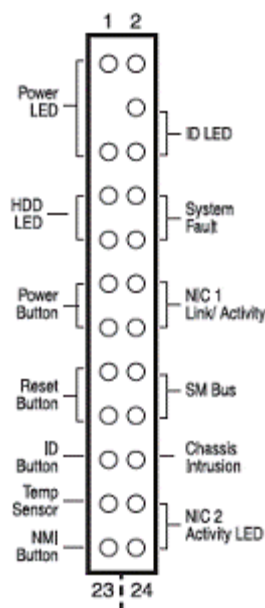
#### 4. Front panel pin-out in the Intel® Server Board S5000PAL Quick Reference Label is incorrect

Problem: The current diagram incorrectly lists a cooling status pin, does not have the temperature sensor listed, and shows incorrect locations for the ID LED. The corrected diagram is shown:

Implication: This is a typo.
