# Monthly Specification Update

## *Intel® Workstation Board S5520SC*

*Intel Order Number E68106-019*

**March, 2011**

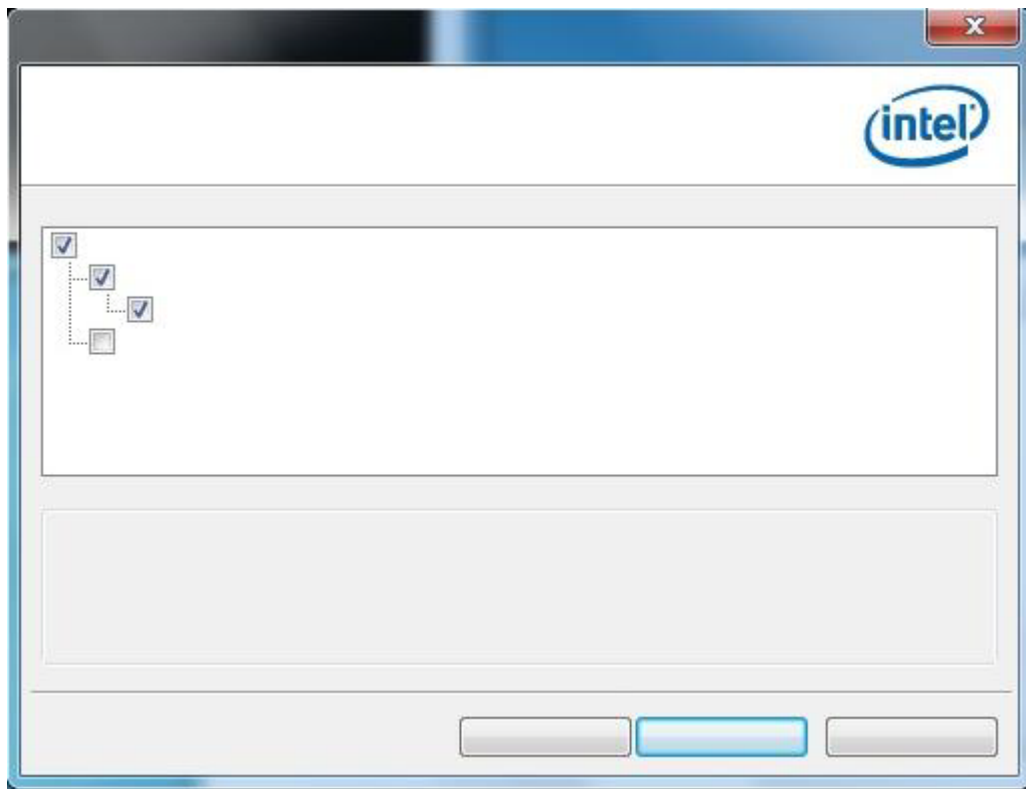
## 30. NIC driver 15.1.1 may not be installed properly in Microsoft Windows Vista\* or Microsoft Windows 7\*

Problem	Users may find onboard NIC (Network Interface Card) driver version 15.1.1 may not get installed properly in Microsoft Windows Vista* or Microsoft Windows 7* when UAC (User Access Control) is set as "Default". Problem may occur during the installation process of the NIC driver, scramble display and unexpected message may display as following:
---------	---

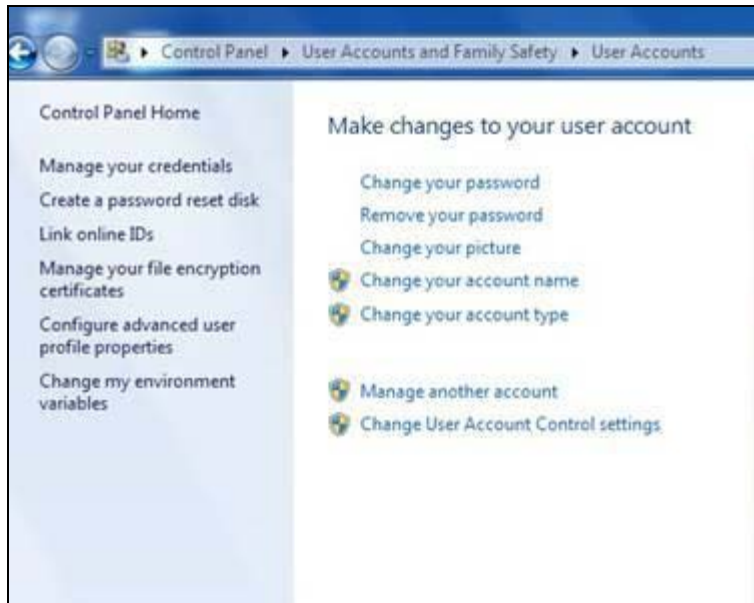
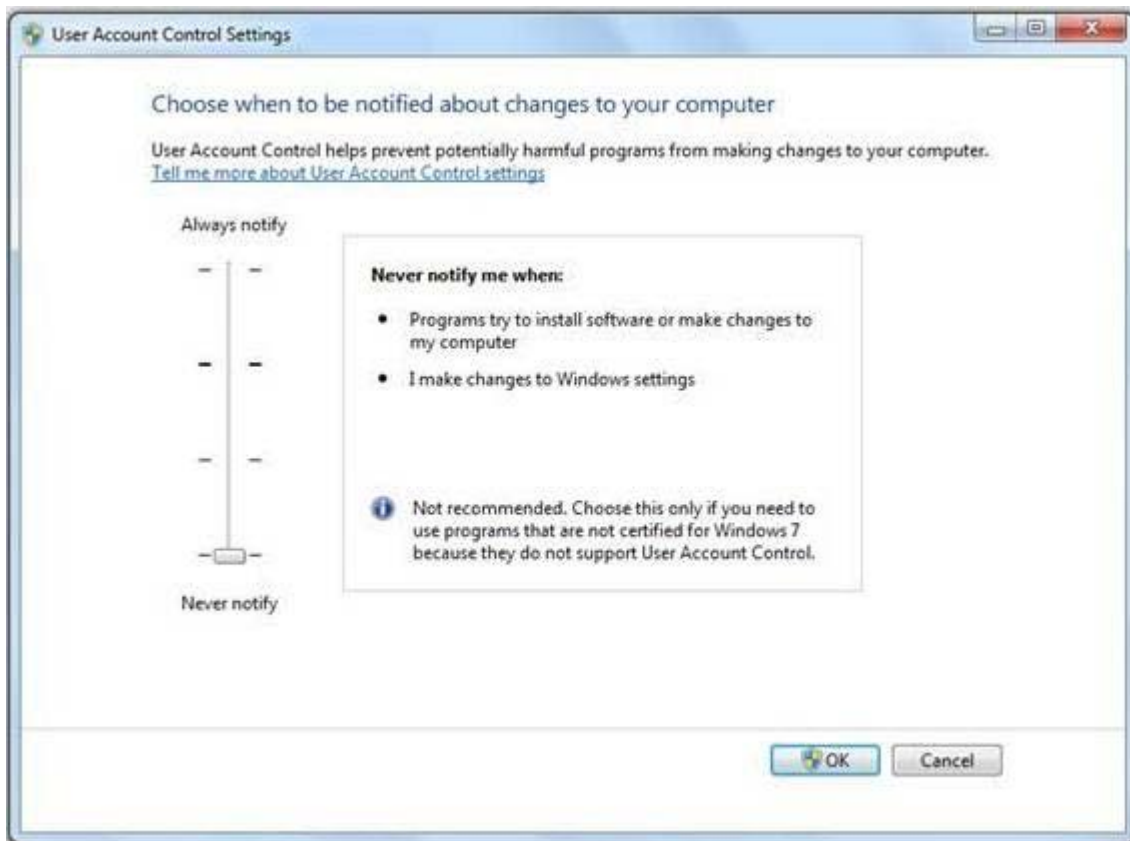
- Implication** This is a permissions issue with Microsoft Windows Vista\* and later operating systems. Permissions don't get elevated installing with PROSETDX.MSI, which is the file the batch file in the root directory points to. DXsetup gets the permissions elevated on Microsoft Windows Vista\* and later operating systems, but they don't get elevated if you launch the MSI without DXsetup.
- Status** This issue will be fixed by future NIC driver release.
- Workaround** The following workaround can be used to navigate around the issue.
1. Users can browse to the \apps\prosetdx\  - 2. Users can also refer to below picture to set Windows UAC (User Account Control) to "Never notify", re-install the driver after a system reboot.
