Monthly Specification Update

Intel® Workstation Board S5520SC

Intel Order Number E68106-023

September, 2011

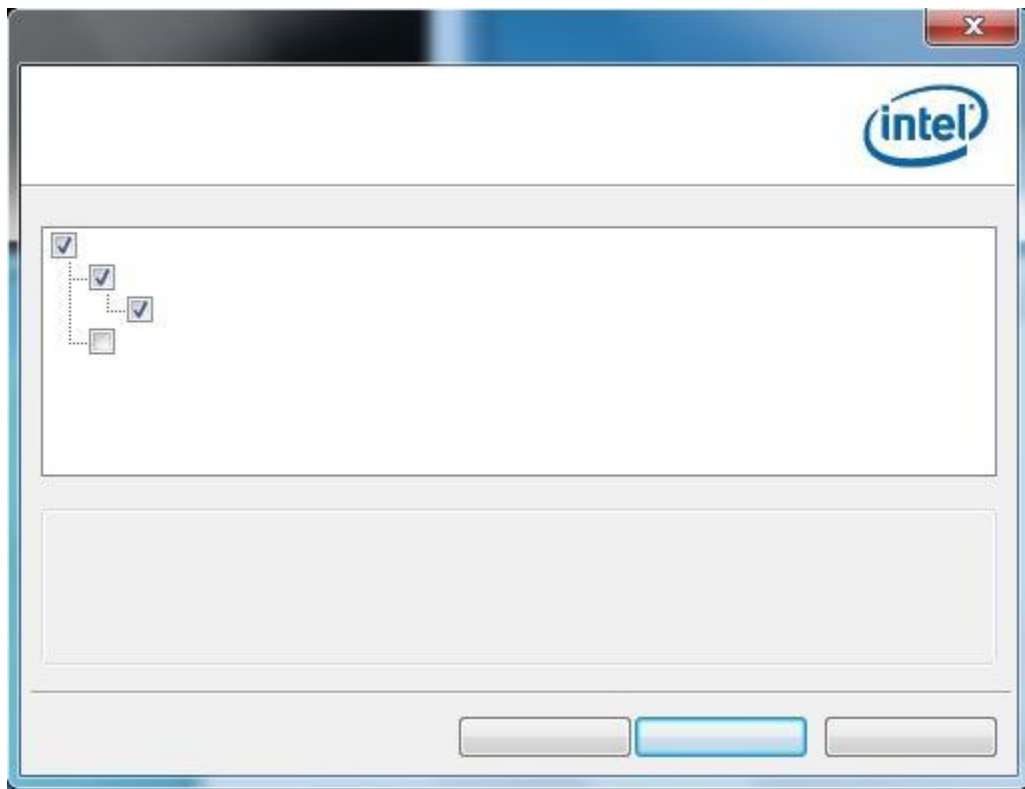
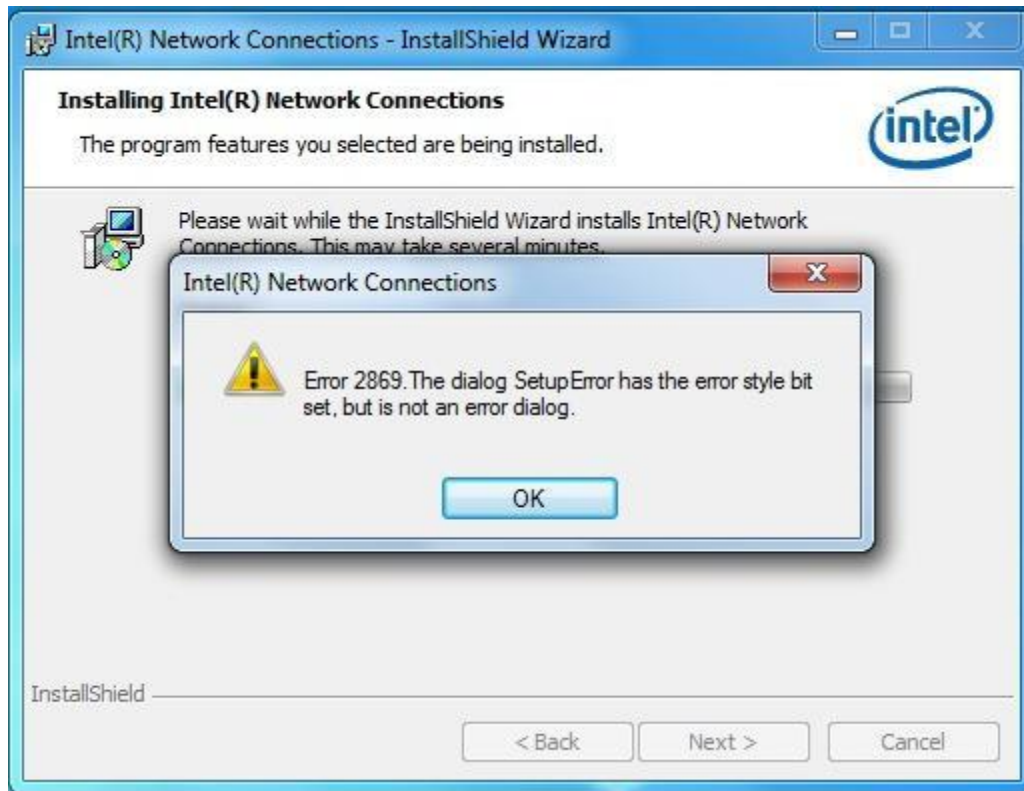
Problem	Users may find onboard NIC (Network Interface Card) driver version 15.1.1 may not get installed properly in Microsoft Windows Vista* or Microsoft Windows 7* when UAC (User Access Control) is set as "Default". Problem may occur during the installation process of the NIC driver, scramble display and unexpected message may display as following:
---------	---

- Implication** This is a permissions issue with Microsoft Windows Vista* and later operating systems. Permissions don't get elevated installing with PROSETDX.MSI, which is the file the batch file in the root directory points to. DXsetup gets the permissions elevated on Microsoft Windows Vista* and later operating systems, but they don't get elevated if you launch the MSI without DXsetup.
- Status** This issue will be fixed by future NIC driver release.
- Workaround** The following workaround can be used to navigate around the issue.
1. Users can browse to the \apps\prosetdx\ - 2. Users can also refer to below picture to set Windows UAC (User Account Control) to "Never notify", re-install the driver after a system reboot.
