Monthly Specification Update

Intel® Server Board S5520UR

Intel Order Number E69054-001

Aug 2011

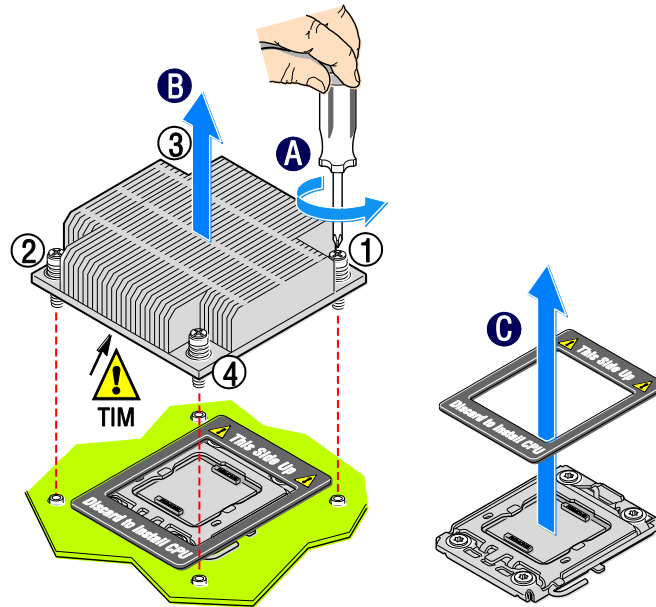
Figure 1. Removing the Heatsink

Problem: The current documentation does not properly describe the installation and removal of the heatsink. Careful insertion and removal of the heatsink is required to prevent damage to the heatsink screws or backplate.

Implication: There is a possibility of damage to the heatsink if proper steps are not followed.

1. Loosen the four captive screws on the heatsink corners in a diagonal manner according to the numbers shown in figure 1 as follows:
 - Starting with the screw at location 1, loosen it by giving it **two rotations** in the anticlockwise direction and stop. (**IMPORTANT:** Do not fully loosen.)
 - Proceed to the screw at location 2 and loosen it by giving it two rotations and stop.
 - Loosen screws at locations 3 and 4 by giving each screw two rotations and then stop.
 - Repeat steps 1a through 1c by giving each screw two rotations each time until all screws are loosened.
2. Do one of the following:
 - If removing the heatsink for the first time, do the following:
 - i. Lift the heatsink from the board.
 - ii. Remove and discard the spacer (see letter “C” in figure 1).
