# Monthly Specification Update

Intel® Server Board S5520UR

*Intel Order Number E69054-001*

**Dec 2011**

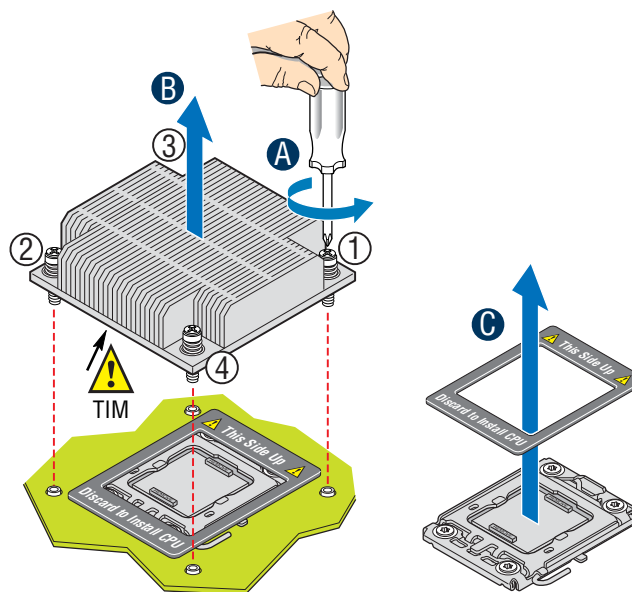
Figure 1. Removing the Heatsink

- Problem:** The current documentation does not properly describe the installation and removal of the heatsink. Careful insertion and removal of the heatsink is required to prevent damage to the heatsink screws or backplate.
- Implication:** There is a possibility of damage to the heatsink if proper steps are not followed.
- Status:** Corrections incorporated into the latest version of the following Service Guides:
- Intel® Server System SR1600 Service Guide (Intel Order Number: E52880-003)
  - Intel® Server System SR1625 Service Guide (Intel Order Number: E52881-003)
  - Intel® Server System SR2600/SR2625 Service Guide (Intel Order Number: E51243-003)
- Workaround:** Perform the steps outlined below for installation and removal of the heatsink to avoid damage.

1. Loosen the four captive screws on the heatsink corners in a diagonal manner according to the numbers shown in figure 1 as follows:
  - Starting with the screw at location 1, loosen it by giving it **two rotations** in the anticlockwise direction and stop. (**IMPORTANT:** Do not fully loosen.)
  - Proceed to the screw at location 2 and loosen it by giving it two rotations and stop.
  - Loosen screws at locations 3 and 4 by giving each screw two rotations and then stop.
  - Repeat steps 1a through 1c by giving each screw two rotations each time until all screws are loosened.
2. Do one of the following:
  - If removing the heatsink for the first time, do the following:
    - i. Lift the heatsink from the board.
    - ii. Remove and discard the spacer (see letter "C" in figure 1).

- If a processor is already installed, do the following:
  - i. Twist the heatsink slightly to break the seal between the heatsink and the processor.
  - ii. Lift the heatsink from the processor. If it does not pull up easily, twist the heatsink again. Do not force the heatsink from the processor. Doing so could damage the processor.
