# Monthly Specification Update

Intel® Server Board S5520UR

*Intel Order Number E69054-001*

**July 2011**

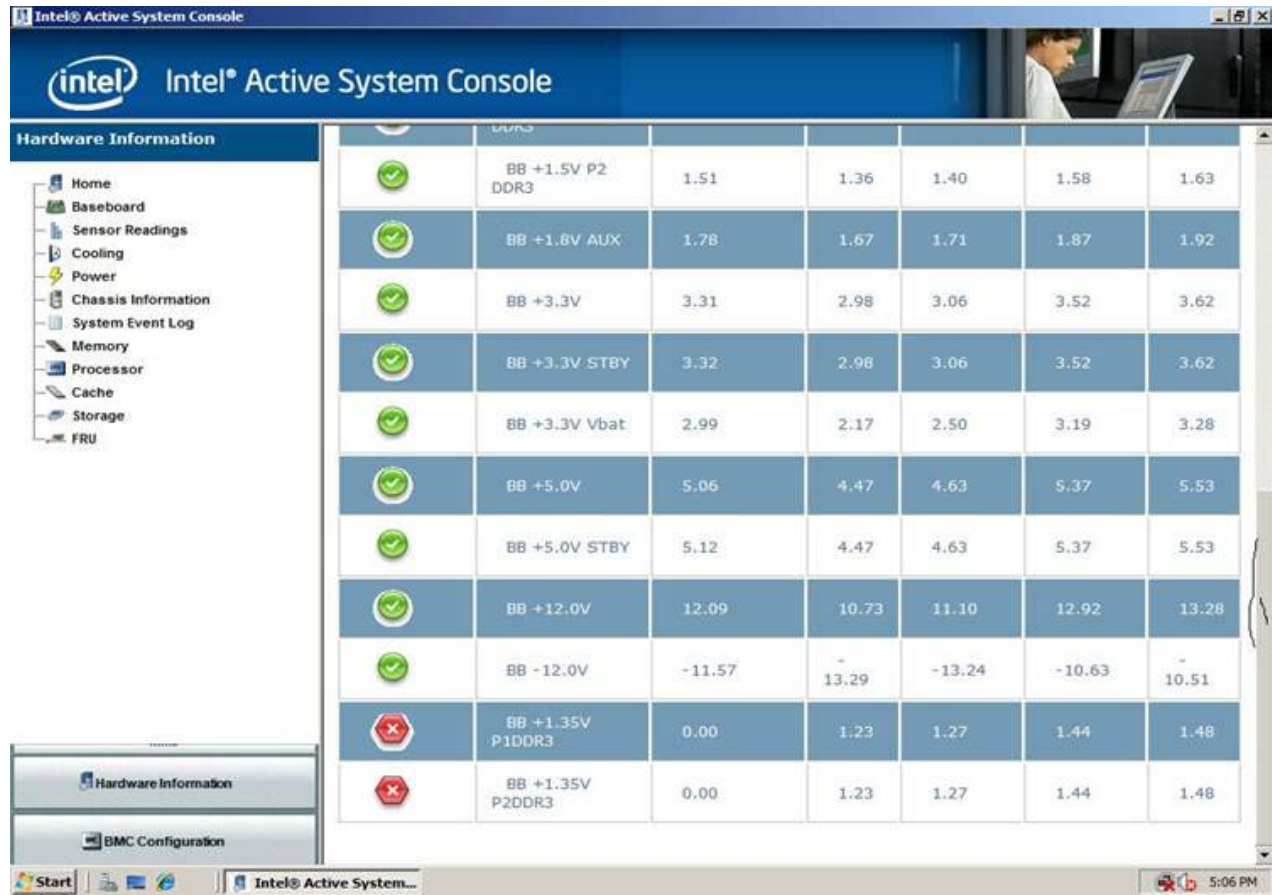
### 37. Intel(R) Active System Console (IASC) 3.5.1 and 3.5.2 may fail to detect status of memory voltage sensors

**Implication** IASC fails to judge the status of disabled sensors and still considers those sensors to server health algorithm.

**Status** This issue will be fixed on next IASC release.
