Monthly Specification Update

Intel® Server Board S5520UR

Intel Order Number E69054-001

June 2013

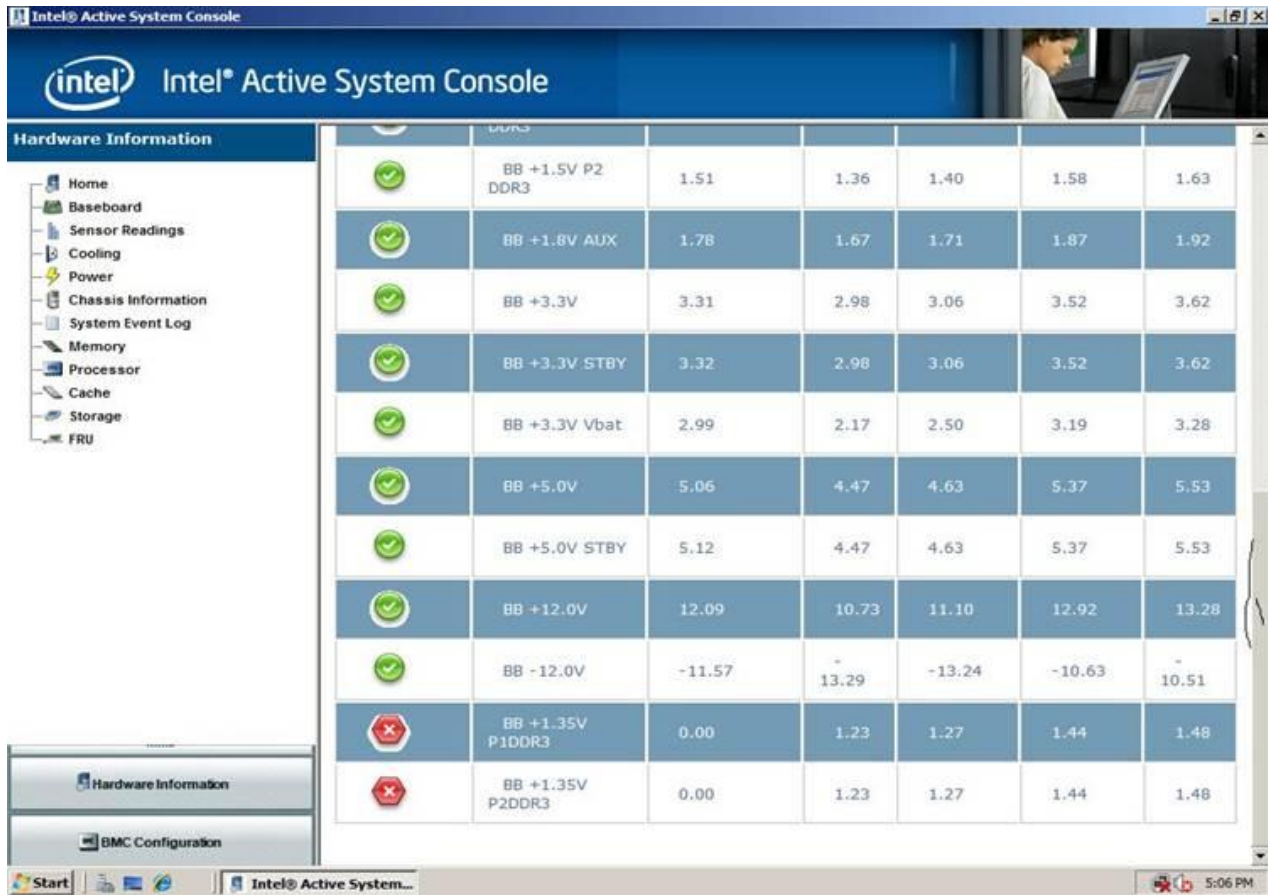
37. Intel(R) Active System Console (IASC) 3.5.1 and 3.5.2 may fail to detect status of memory voltage sensors

Implication IASC fails to judge the status of disabled sensors and still considers those sensors to server health algorithm.

Status This issue will be fixed on next IASC release.
