# Monthly Specification Update

**Intel® Server Board S5520UR**

*Intel Order Number E69054-001*

**Sep 2012**

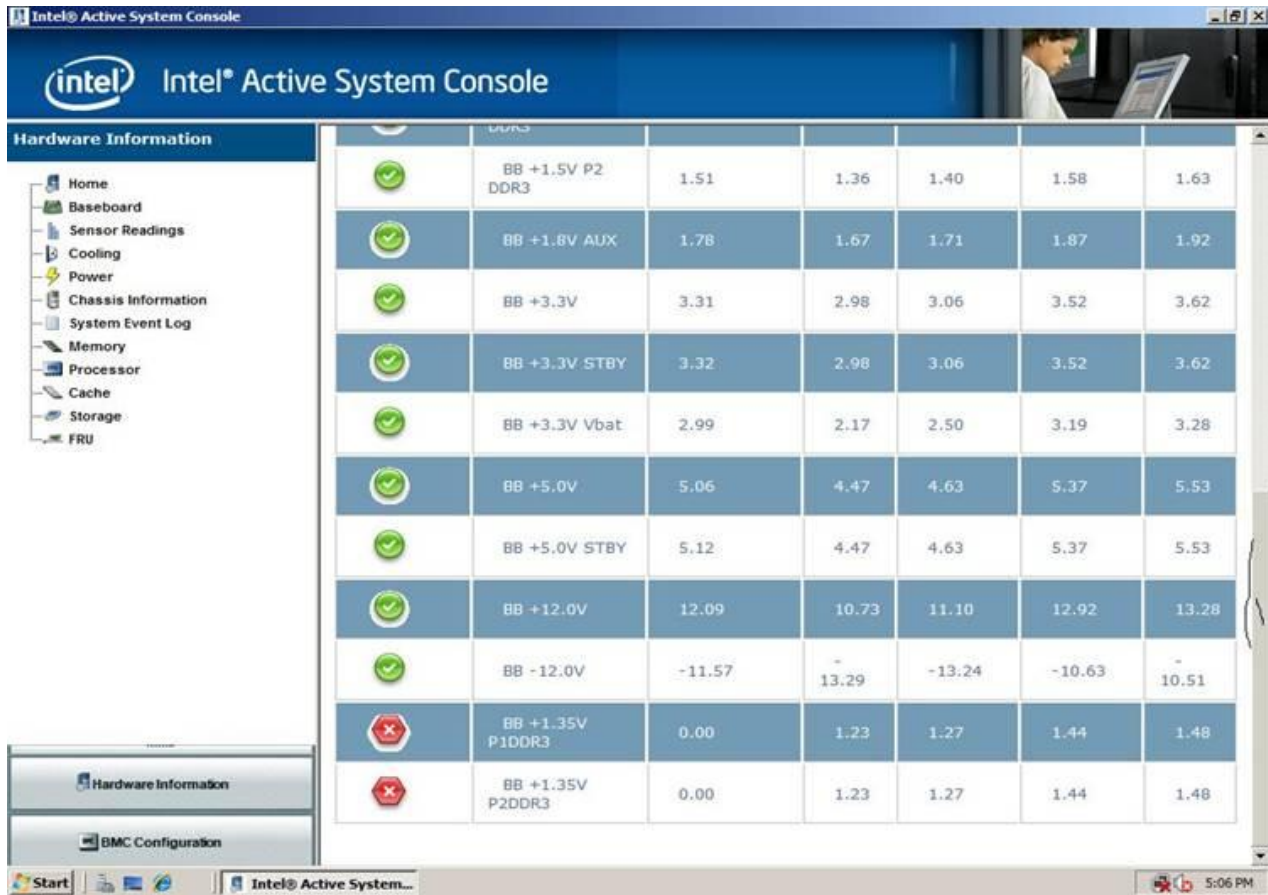
### 37. Intel(R) Active System Console (IASC) 3.5.1 and 3.5.2 may fail to detect status of memory voltage sensors

Problem	<p>Intel® Active System Console (IASC) v3.5.1 and v3.5.2 is used to monitor hardware status on Intel server system.</p> <p>Intel® Server Board S5520UR start to support low voltage memory DIMM, so current FRUSDR has contained four memory voltage sensors "BB+1.5v P1DDR3", "BB+1.5v P2DDR3", "BB+1.35v P1DDR3" and "BB+1.35v P2DDR3", When system has 1.5v memory or 1.35v memory, only corresponding memory voltage sensors will be enabled, the other type memory voltage sensors will be disabled.</p> <p>IASC cannot judge the status of memory voltage sensors which have been disabled, and still try to detect those sensors reading. Because sensor reading is "0", lower than its threshold, so IASC shows those sensors status as critical warning.</p> <p>Below is screen shoot of this failure</p>
---------	--

**Implication** IASC fails to judge the status of disabled sensors and still considers those sensors to server health algorithm.

**Status** This issue will be fixed on next IASC release.

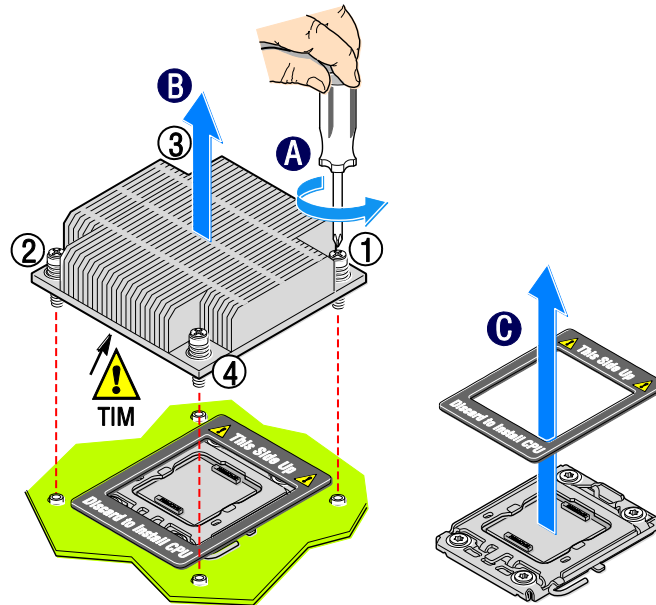
**Figure 1. Removing the Heatsink**

**Problem:** The current documentation does not properly describe the installation and removal of the heatsink. Careful insertion and removal of the heatsink is required to prevent damage to the heatsink screws or backplate.

**Implication:** There is a possibility of damage to the heatsink if proper steps are not followed.

1. Loosen the four captive screws on the heatsink corners in a diagonal manner according to the numbers shown in figure 1 as follows:
  - Starting with the screw at location 1, loosen it by giving it **two rotations** in the anticlockwise direction and stop. (**IMPORTANT:** Do not fully loosen.)
  - Proceed to the screw at location 2 and loosen it by giving it two rotations and stop.
  - Loosen screws at locations 3 and 4 by giving each screw two rotations and then stop.
  - Repeat steps 1a through 1c by giving each screw two rotations each time until all screws are loosened.
2. Do one of the following:
  - If removing the heatsink for the first time, do the following:
    - i. Lift the heatsink from the board.
    - ii. Remove and discard the spacer (see letter “C” in figure 1).

- If a processor is already installed, do the following:
  - i. Twist the heatsink slightly to break the seal between the heatsink and the processor.
  - ii. Lift the heatsink from the processor. If it does not pull up easily, twist the heatsink again. Do not force the heatsink from the processor. Doing so could damage the processor.
