Monthly Specification Update

Intel® Server Boards S2600WP Family
Intel® Server Systems H2000WP Family

Intel Order Number G64830-003

October, 2012

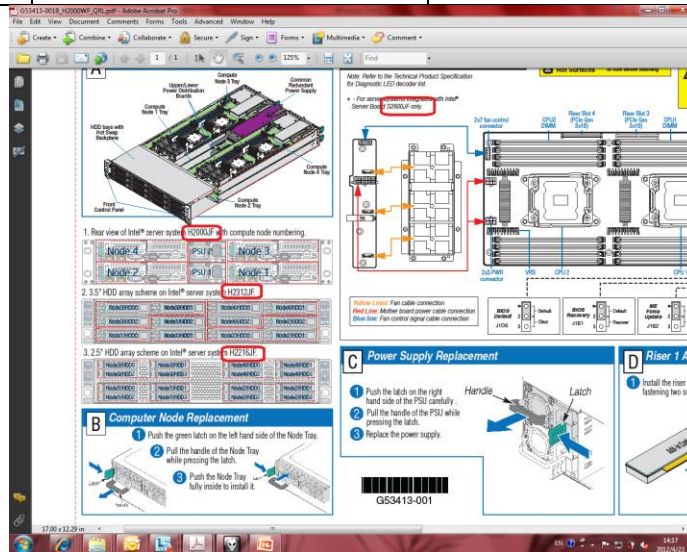
Problem The Intel® Server System H2000WP family Chassis Quick Reference(document ID G53413-001) has 4 incorrect picture titles as shown below. The correct title name should be “H2000WP”, “H2312WP” “H2216WP” and “S2600WP”. All schemes and configuration diagrams are correct for H2000WP. The impacted servers systems are listed below. The updated Chassis Quick Reference (document ID G53413-002) has fixed this problem. The impacted server systems are list in the table

The Chassis Quick Reference with incorrect picture titles

- Implication The picture tiles do not match the pictures.
- Status This issue was fixed with G53413-002.
- Workaround None.

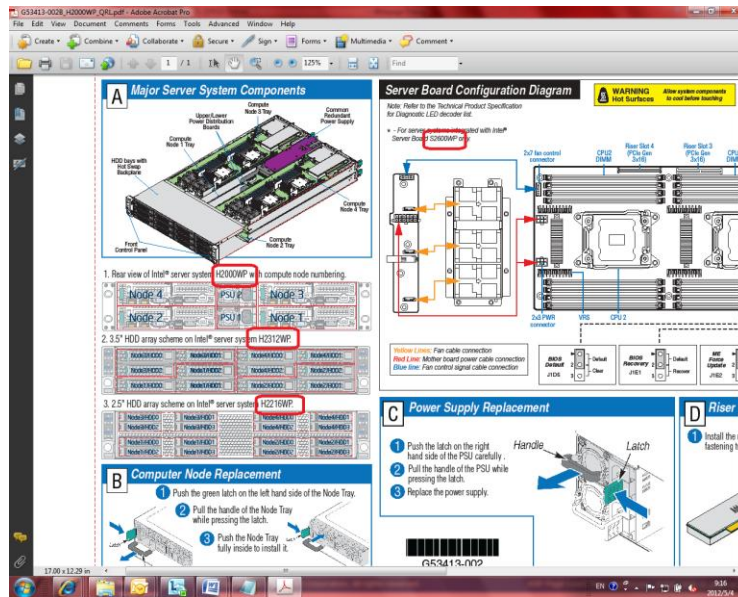
The Chassis Quick Reference with updated picture titles
