Intel Technical Advisory

TA-0946-1

Intel® Server System SR1630HGP SGPIO Cable May Be Plugged Into Wrong Connector

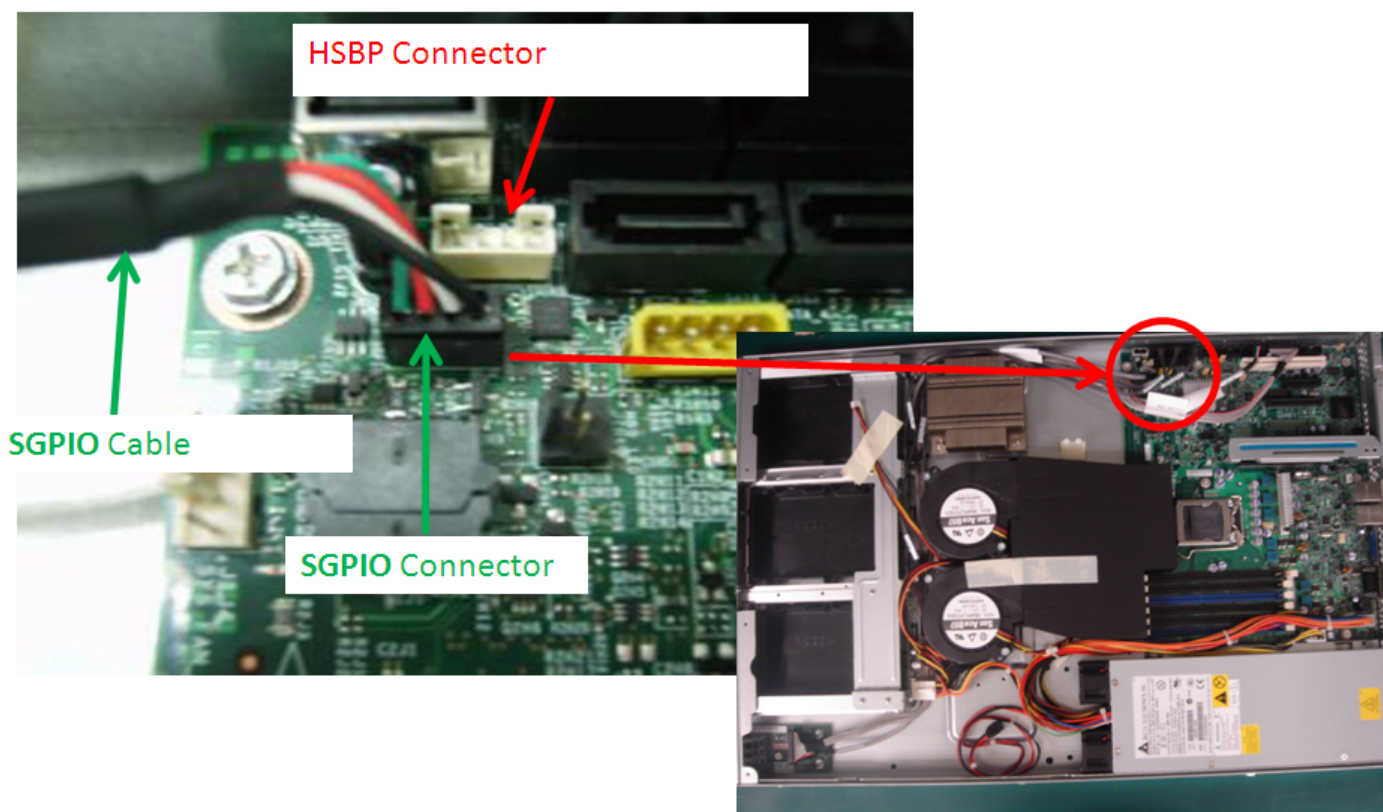
Intel has discovered an issue with the server products listed above in which the SGPIO cable is plugged in the wrong connector on the server board. The SGPIO cable should be plugged in the black SGPIO connector. But in some systems the SGPIO cable was incorrectly plugged in the white HSBP (Hot Swap Backplane) connector. These two connectors are pin compatible; therefore different colors are used to distinguish the connectors. Figure 1 shows the SGPIO cable when it is correctly plugged into the black SGPIO connector.

Figure 1 Correct SGPIO Cabling Installation

Customers can check the HDD Activity LED light behavior. If any of the LED's are unexpected lit and the system built date was before WW11, 2010, customers may refer to the Figure 1 to check the SGPIO cable connection and correct it accordingly. For the top cover disassembly procedure, please refer to Intel® Server System SR1630HGP Quick Start User's Guide on the Intel® Server Deployment Toolkit CD or at <http://www.intel.com/support/motherboards/server/s3420gp/sb/CS-030745.htm>.

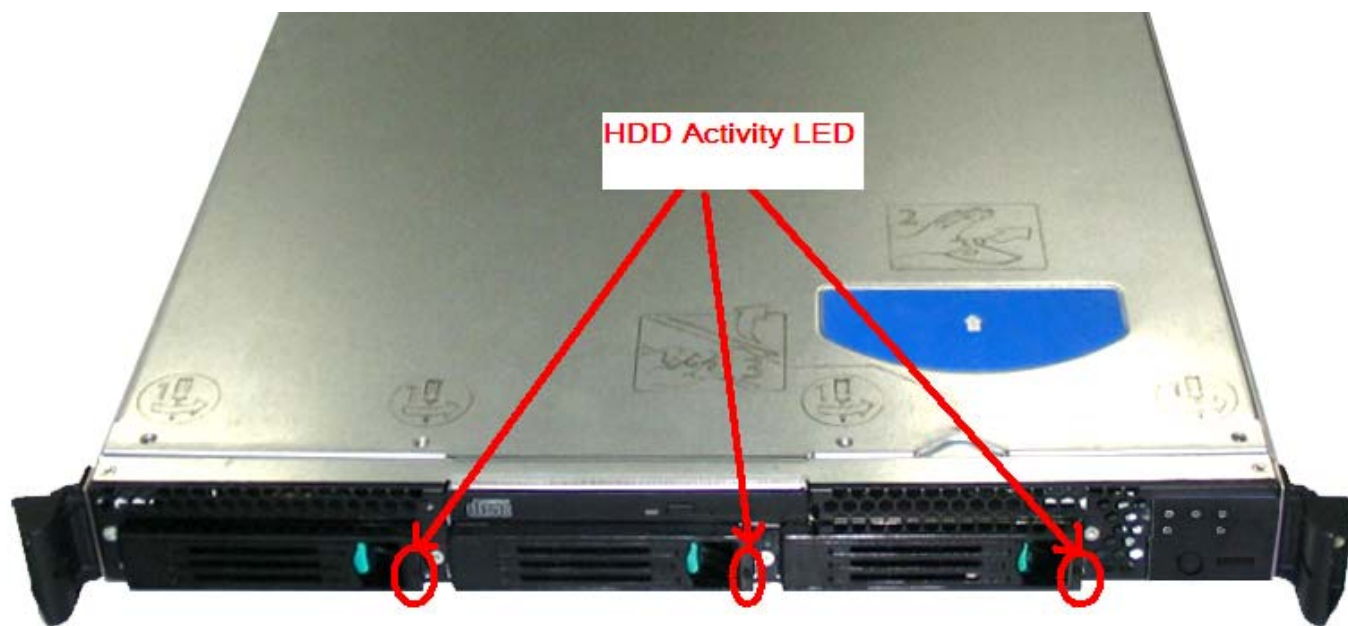
When the SGPIO cable is mistakenly plugged into the HSBP connector, the Hard Disk Drive (HDD) activity LED from the hot swap slot could light up unexpectedly. These three HDD activity LEDs (either amber or green) may incorrectly be lit and stay on.

Figure 2 HDD Activity LED location

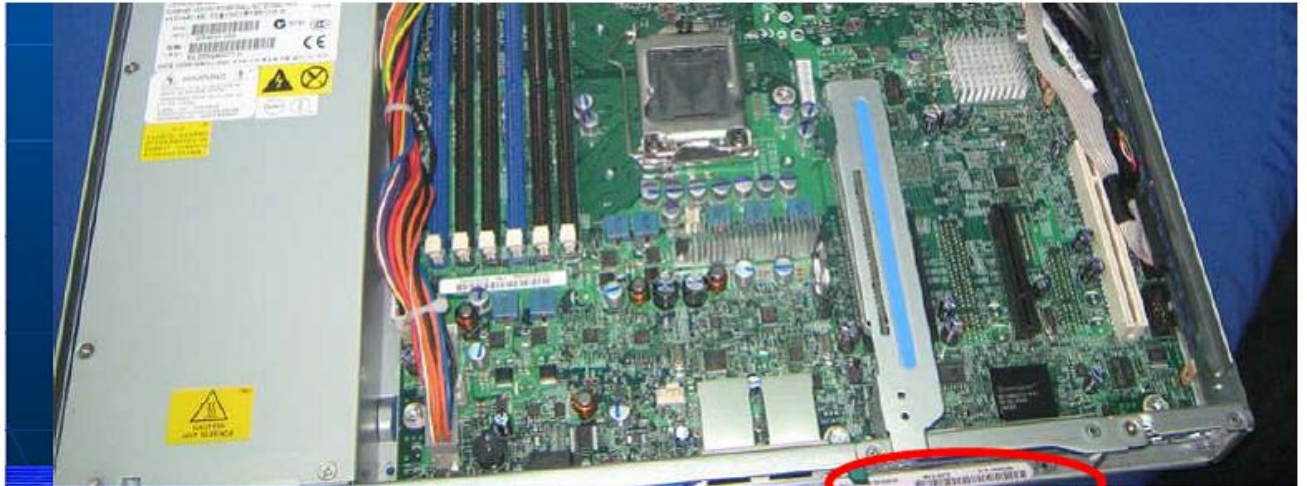
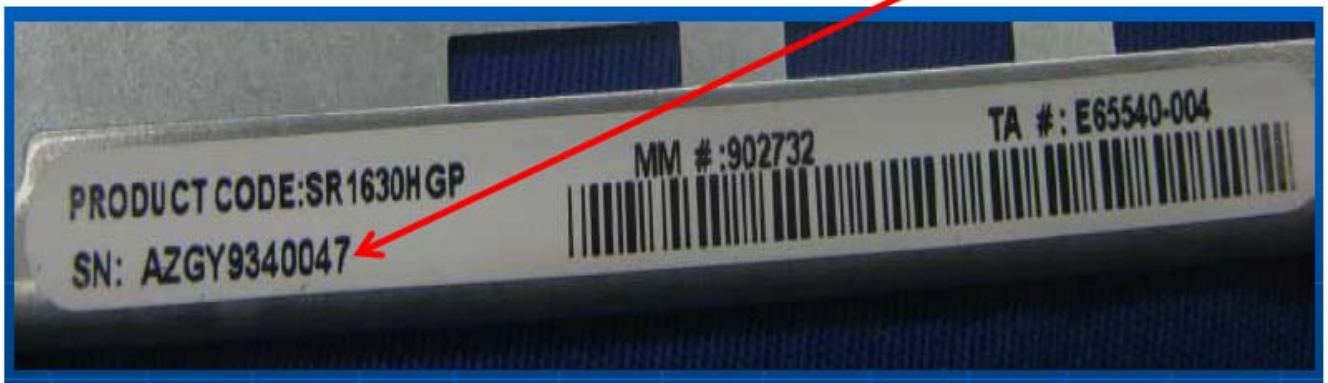
Figure 3 System Serial Number Sticker Location

Intel implemented corrective action in the factory assembly line starting with products carrying the system Serial Number AZGY0110001 and later. Please refer to Figure 3 and 4 for the location and definition of the Serial Numbers.
