# intel® Technical Advisory

TA-0791-1

September 16, 2005

## Some EMI shields are difficult to remove from the floppy/HDD tray included with the Intel® Server Chassis SC5300

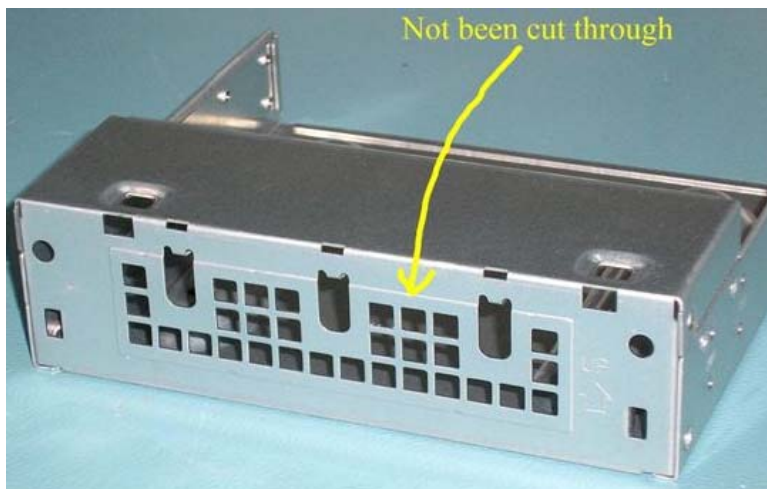
In some systems, the EMI shield in the floppy/HDD tray may not have been completely cut through making removal of the shield for floppy drives very difficult to do. Normal removal of the EMI shield should only require light to moderate force pushing from inside of the tray and possibly light manipulation with a screw driver to break the tabs.

The alignment of the tooling used to manufacture this part went outside of the part specification.

The tool has been realigned at the factory, and it has been confirmed to correctly punch the EMI shield in the tray. If you have a tray with this issue, you may return it to Intel for a corrected replacement tray. To get parts, contact Intel using your normal warranty process. Please indicate that you are calling regarding TA# 0791-1, and have the following information when you call; the part number requested (p/n for this issue is **52131581**), and the serial number(s) for the system(s) needing the replacement part.
