intel® Technical Advisory

TA-730-1

November 3rd, 2004

Intel® Server Board SE7520BD2V boxboards may contain an incorrect IO Shield

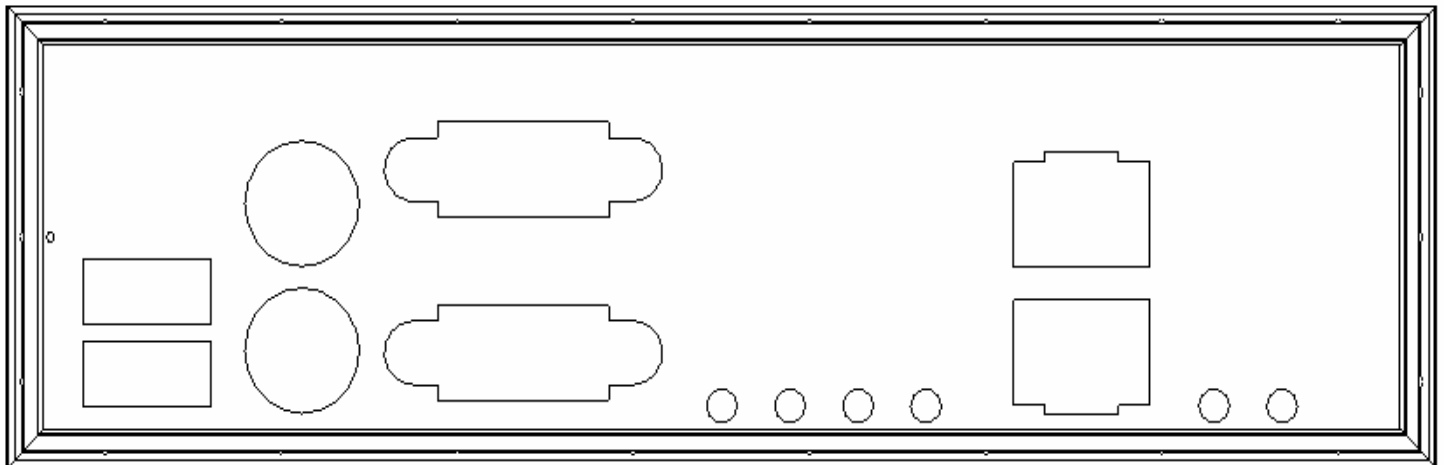
Figure 1: Correct I/O shield for the SE7520BDV boxboard.

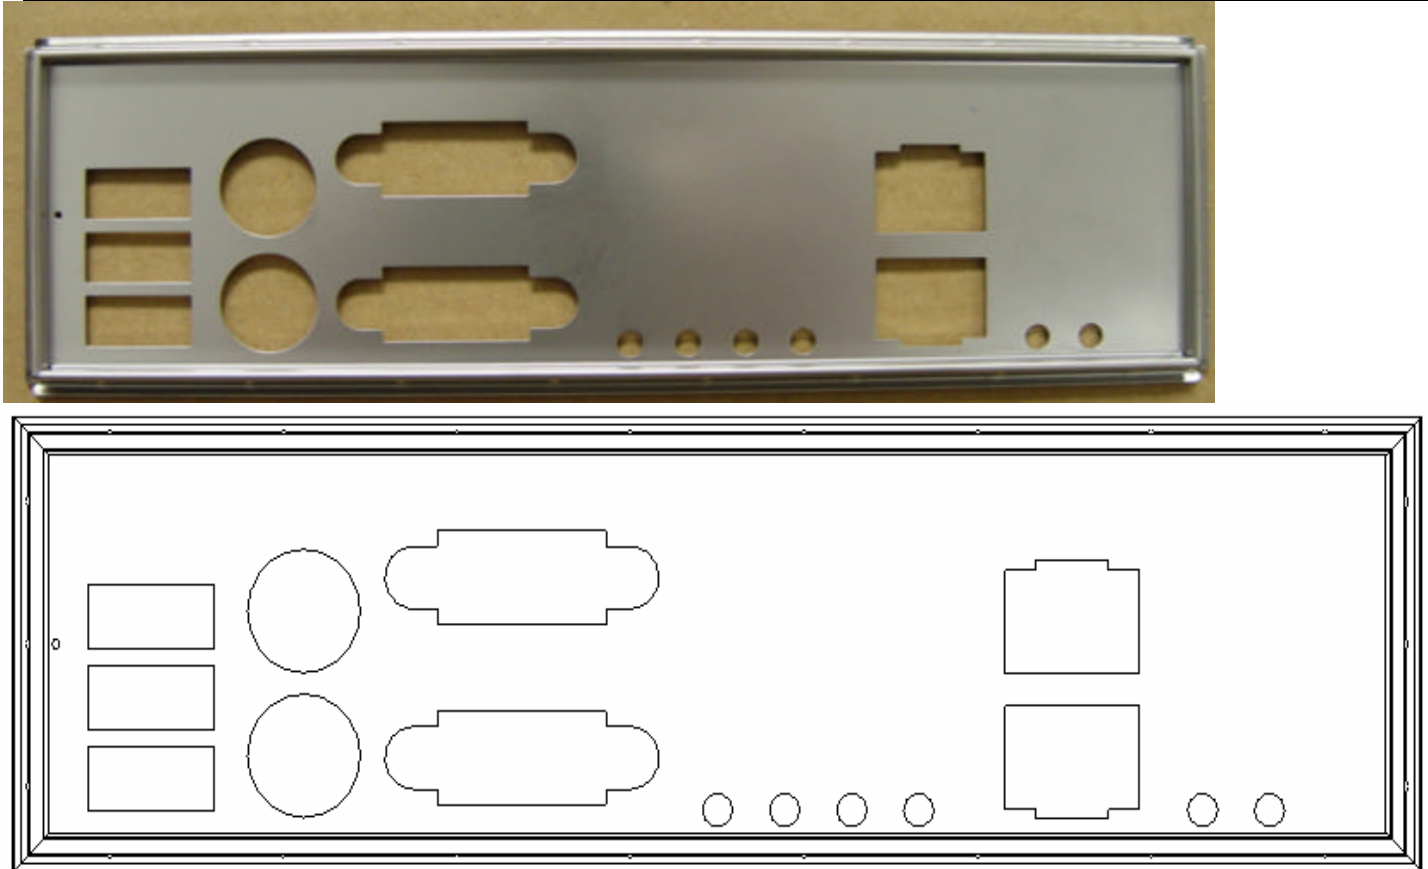
The Intel® SE7520BD2V Server Board boxboard was manufactured with the wrong I/O Shield. The correct I/O shield requires two holes for external USB connectors. However, initial shipments listed in **products affected** section above may contain an I/O shield with three external USB holes. You can determine if your boxboards contain the correct I/O by referring to **Figure 1**. **Figure 2a, b** represent the incorrect 3-holed USB shields. Without the correct I/O shield your selected chassis may fail to pass EMI validation testing.

Figure 2a, b: Incorrect I/O Shield with three USB holes for the SE7520BDV boxboard

During Manufacturing the factory incorrectly placed the Intel® Server Board SE7520BD2SCSI I/O shield in the SE7520BDV boxboard.

Please contact Intel Customer Support to obtain a replacement I/O shield for the SE7520BD2V boxboards and reference TA 730-1 or use your normal warranty support process to request replacement I/O shields for all SE7520BDV boxboards. You may also contact your Intel Sales Representative if you require more specific information about this issue.
