intel[®] Action Alert

AA-0746-2 (Update)

February 10, 2005

Intel[®] Server Board SE7520JR2 – Heat Sink Fastener Pins Not Fully Inserted

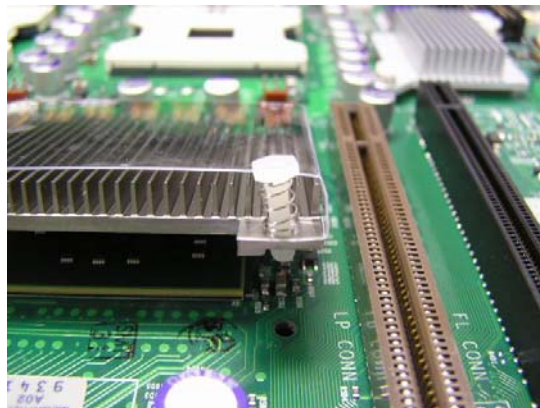
Intel has recently been made aware of an issue with some SE7520JR2 server boards where a heat sink retention pin was found disengaged causing the affected heat sink to move from its required position.

Through factory process inspection, Intel has determined that inconsistent pressure was being used to insert the heat sink retention pins from one board to the next. Retention pins that were not fully inserted into the baseboard did not have their tabs fully expanded allowing for potential disengagement during shipping due to excessive shock or vibration.

For affected products stocked in its warehouses the week of January 17, 2005, Intel has inspected, and where necessary reworked, all boards. All new builds starting from January 18th, 2005 and going forward will have heat sinks mounted using a new process including an end of line visual inspection. Boards assembled with the new process will have a serial number starting at BZJR504xxxxx.

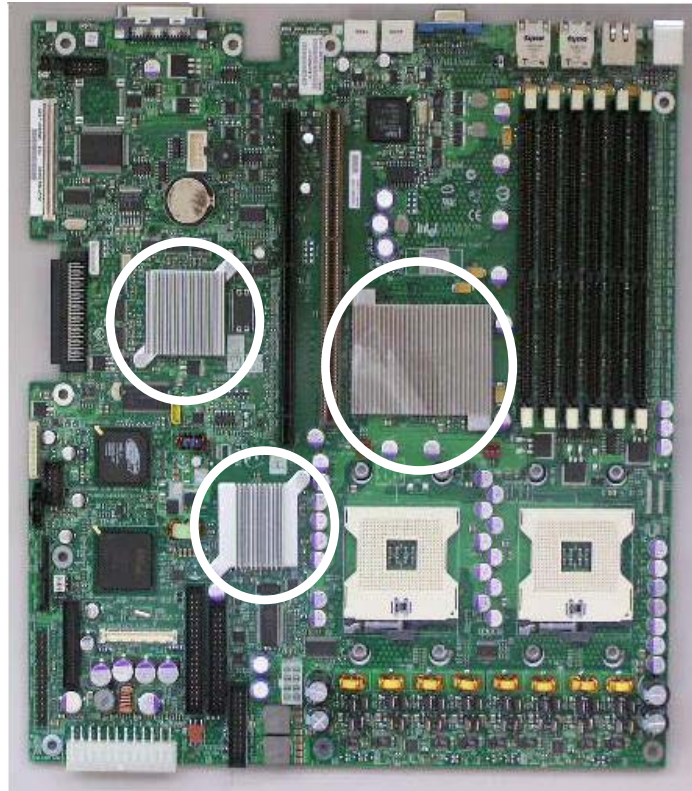
As shown in the following photograph, the Intel Server Board SE7520JR2 has three on-board heat sinks that may be affected by this issue.

Note: SATA only SKUs of the SE7520JR2 will only have 2 heat sinks, bottom middle and top right as pictured above.

Intel recommends that customers with in-house inventories that fall within the specified board serial number range visually screen for possible heat sink pin disengagement and manually check that all heat sink pins are fully engaged. Based on the visual screen results, Intel recommends the following:

- 1) If a heat sink is found to be fully removed from the baseboard, Intel recommends that the board be returned using the standard RMA process. These boards have a potential of other component damage due to heat sink contact during shipping.

- 2) If a single heat sink retention pin has disengaged and the heat sink has pivoted from its normal position, Intel recommends that the components around the affected heat sink be visually inspected for damage. If no damage is found, the heat sink can be moved back to its normal position and the loose pin pushed down into place far enough to have its tabs spread open under the baseboard. If component damage is found, the board should be returned using the standard RMA process.

- 3) If a heat sink pin has disengaged but the heat sink is still in its normal position over the chip, Intel recommends that the pin be pushed back down far enough to have its tabs spread open underneath the baseboard.
