intel® Technical Advisory

TA-669-3

September 25, 2003

Intel® Server Chassis SC5200 SAF-TE Controller Crystal Operating Outside Design Specifications

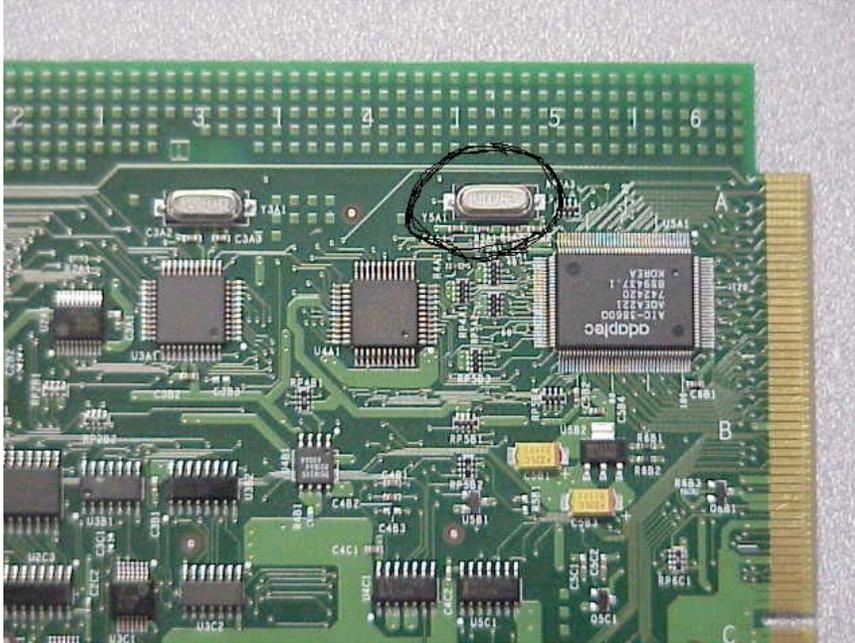
- Product built between June 30, 2003 (WW~~27~~) and September 5, 2003 (WW~~36~~)
- Product bearing the Serial Numbers: IMJR3~~27~~XXXXXX through IMJR3~~36~~XXXXXX
 - Decode Mechanism is: First Digit=Year=2003, Second and Third digits=Work-Week, X=Don't Care (DC)
- Crystal in location Y5A1 on the SAF-TE card is marked with “40.0[N] XXXX”

- Product built **before** June 30, 2003 (Serial #: IMJR3~~26~~XXXXXX) **OR** **after** September 5, 2003 (Serial #: IMJR3~~37~~XXXXXX)
- System configuration is SCSI only (i.e., use SCSI drives in “non-RAID” configurations only)
- System configuration is a non-SAF-TE RAID
- Crystal in location Y5A1 on the SAF-TE card is marked with “R400 XXXX”

1. Remove hot swap drive bay from the Intel Server Chassis SC5200 chassis (for chassis products).
2. Remove the white plastic piece (part number 743492-004) attached to the hot swap backplane bay with four screws.
3. Remove the hot swap backplane board and the attached SAFTE card from the hot swap backplane bay.
4. Find the crystal (silver colored) at location Y5A1 on the SAFTE card (PBA A42862-110). The crystal location is shown in the photograph below.
5. Crystals marked with "R400 XXXX" are NOT affected by this issue. Crystals marked with "40.0 [N] XXXX" are affected by this issue. The XXXX markings are date-code related and should be considered as don't cares for the "crystal" issue

Customers who have material affected by this issue should obtain replacement product through normal warranty procedures. To get parts contact Intel using your normal warranty process. Please indicate that you are calling regarding TA number 669-3, and have the following information when you call; the part number requested, and the serial number(s) for the system(s) or board(s) needing the replacement part.
