# Intel<sup>®</sup> Celeron<sup>®</sup> Processor Specification Update

Release Date: May 2007

Document Number: 243748-050

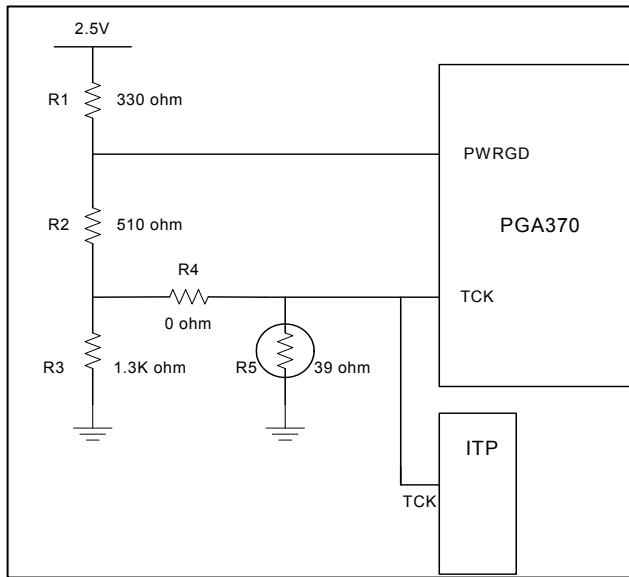
Figure 1 Celeron® on 0.13 Micron Processor 256K Platforms Workaround

In addition, the example workaround circuits shown do not support production motherboard test methodologies that require the use of the processor JTAG/TAP port. Alternative workaround solutions must be found if such test capability is required.

For Production Boards:

*Depopulate R5*
