Mobile Intel® Celeron® Processor on .13 Micron Process in Micro-FCPGA Package

Specification Update

October 2005

Document Number: 251309-028

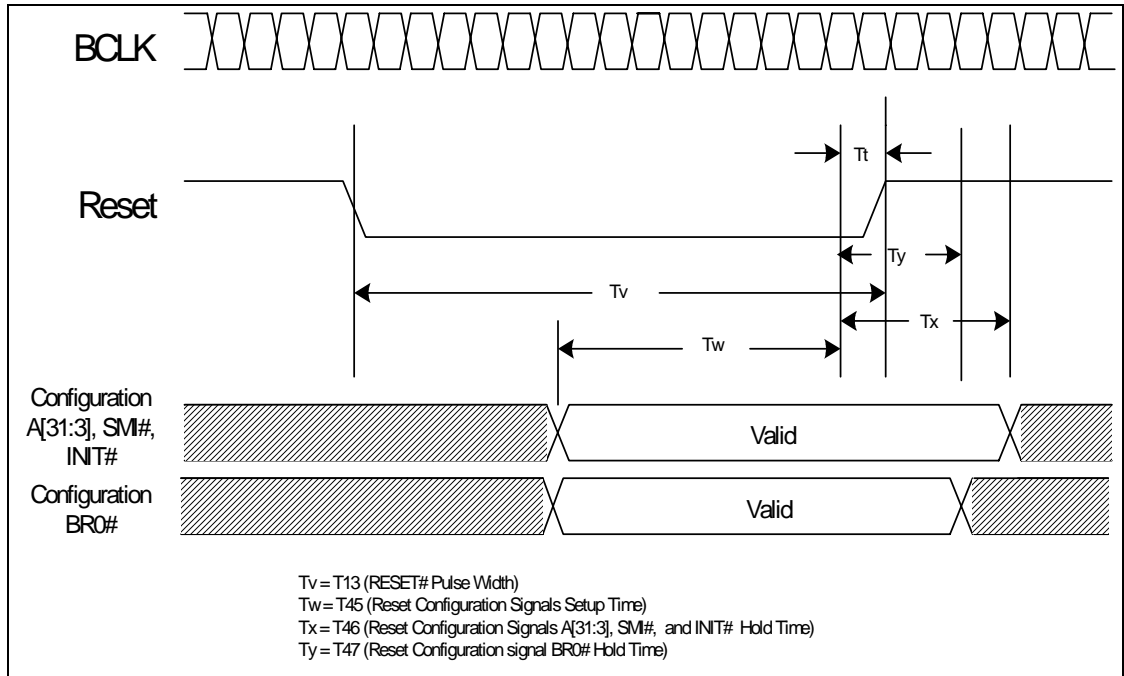
Figure 12. System Bus Reset and Configuration Timings

The BR0# maximum hold time has changed to 2 BCLKs. This change will be shown in the “System Bus AC Specifications (Reset Conditions)” table and “System Bus Reset and Configuration Timings” figure of the *Mobile Intel® Celeron® Processor on .13 Micron Process in Micro-FCPGA Package Datasheet*. This change will be incorporated in the next revision of the datasheet.

The following figure will be modified to reflect this change:
