Late-Breaking News

Note: Read this information before configuring the Intel® Carrier Grade Server TIGW1U. Also be sure to check the support website at <http://www.intel.com/support/telecom/computeboards/tigw1u/> for further late-breaking news, general information, and downloadable BIOS files.

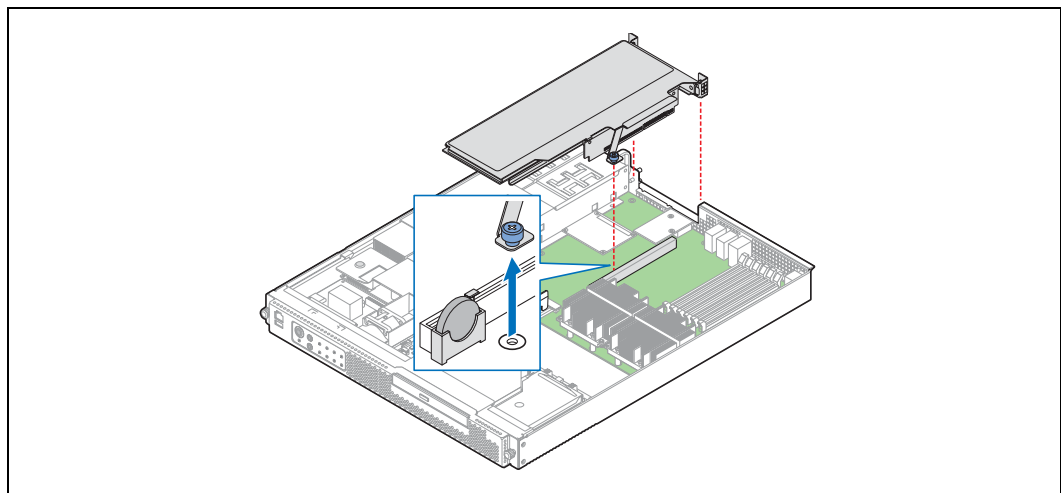
Caution: When removing or installing the riser assembly in an Intel® Carrier Grade Server TIGW1U take particular care not to touch the battery on the server board with the retaining screw bracket or any part of the riser assembly. Touching the battery with a metallic object can reset the bank selection circuitry and possibly cause the next boot to hang during POST.

To ensure the desired version of BIOS is used after removing or replacing the battery, flash the latest BIOS before removing the battery.
