Technical Advisory

TA-2007_NSW1U-1

February 2007

Intel® IP Network Server NSW1U

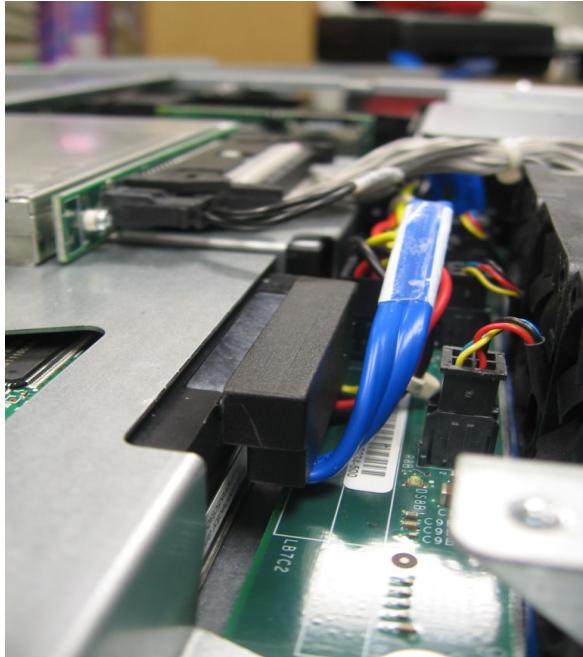
If a SATA drive signal cable is routed such that it touches the Ethernet Front Panel (EFP) board, rotational vibration from the fans may be transmitted to the hard drive through the SATA drive connector. This vibration can affect drive performance under some conditions.

Excessive fan vibration is transmitted to the SATA hard drive though the connector.

When installing the SATA hard drives into the system, do not allow the SATA signal cables to touch the EFP board. The SATA cables exit the SATA drive connectors towards the Ethernet Front Panel (EFP) board and bottom of the chassis, as shown in Figure 1. Fold the cable upwards as it exits the SATA drive connector so it is sure to clear the EFP board.

Figure 1 and Figure 2 show how the longer SATA signal cable from the rightmost drive (bay 0) should arch over the SATA power cables in front of the fan power connectors.

Until a new fan bracket design is implemented, the immediate corrective action is to route SATA drive signal cables high enough so they do not touch the EFP board anywhere and transmit the fan vibration. Figures 1 -- 4 show how to route the signal cable (i.e., large blue cable with the label "SATA cable") by folding it so that it does not lie on the EFP board.

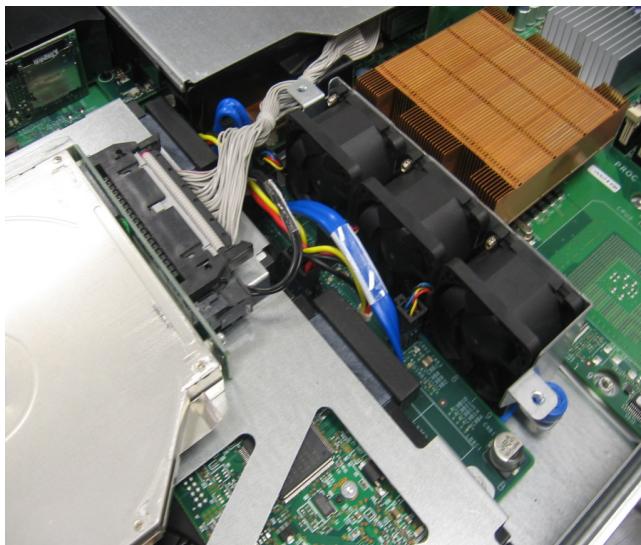
Figure 3 and Figure 4 show how the shorter SATA signal cable from the leftmost drive (bay 1) must be folded sharply on the other side of the optical drive IDE signal cable.
