28F016XS

SPECIFICATION UPDATE

Release Date: November 1996

Order Number 297553-007

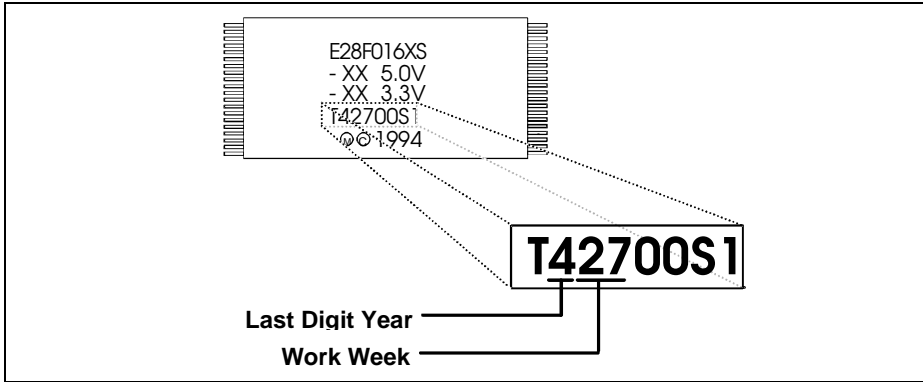
FPO Number Location and Clarification

The Finished Processing Order (FPO) number identifies the device's testing date. The FPO number correlates to a specific Device Version Number, as illustrated below:
