# Monthly Specification Update

Intel® Server Board S5520UR

*Intel Order Number E69054-001*

**July 2011**

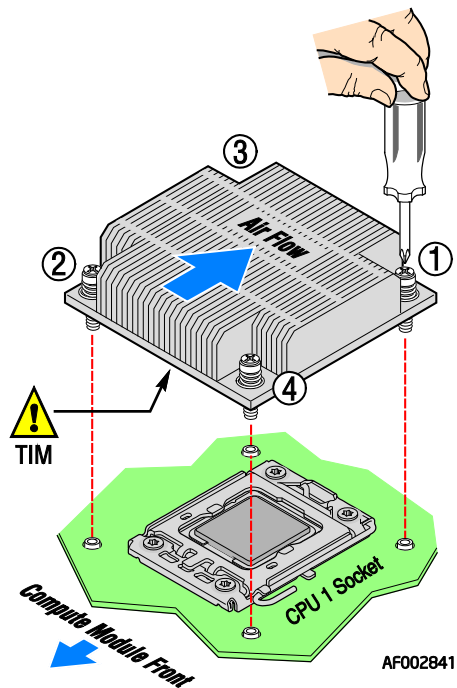
Figure 2: Installing the Heatsink

**Problem:** The current documentation does not properly describe the installation and removal of the heatsink. Careful insertion and removal of the heatsink is required to prevent damage to the heatsink screws or backplate.

**Implication:** There is a possibility of damage to the heatsink if proper steps are not followed.

2. Orient the heatsink over the processor as shown in Figure 2. The heatsink fins must be positioned as shown to provide correct airflow through the system.

3. Set the heatsink over the processor, lining up the four captive screws with the four posts surrounding the processor.
4. Loosely screw in the captive screws on the heatsink corners in a diagonal manner according to the numbers shown in Figure 2 as follows:

- b. Proceed to the screw at location 2 and engage the screw threads by giving it two rotations and stop.
  - c. Engage screws at locations 3 and 4 by giving each screw two rotations and then stop.

- d. Repeat steps 4a through 4c by giving each screw two rotations each time until all screws are lightly tightened upto a maximum of 8 inch-lbs torque.
