Monthly Specification Update

Intel® Server Board S5520UR

Intel Order Number E69054-001

June 2013

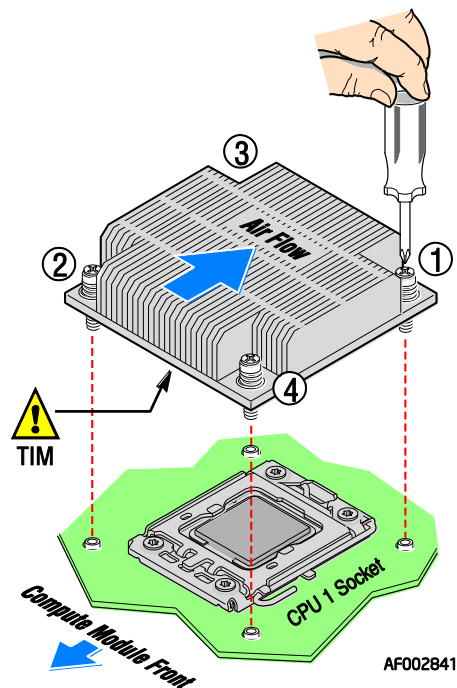
Figure 2: Installing the Heatsink

1. Proper Heatsink Installation and Removal Instructions are missing from Service Guide

Problem: The current documentation does not properly describe the installation and removal of the heatsink. Careful insertion and removal of the heatsink is required to prevent damage to the heatsink screws or backplate.

Implication: There is a possibility of damage to the heatsink if proper steps are not followed.

Workaround: Perform the steps outlined below for installation and removal of the heatsink to avoid damage.

2. Orient the heatsink over the processor as shown in Figure 2. The heatsink fins must be positioned as shown to provide correct airflow through the system.

3. Set the heatsink over the processor, lining up the four captive screws with the four posts surrounding the processor.
4. Loosely screw in the captive screws on the heatsink corners in a diagonal manner according to the numbers shown in Figure 2 as follows:

- b. Proceed to the screw at location 2 and engage the screw threads by giving it two rotations and stop.
 - c. Engage screws at locations 3 and 4 by giving each screw two rotations and then stop.

- d. Repeat steps 4a through 4c by giving each screw two rotations each time until all screws are lightly tightened upto a maximum of 8 inch-lbs torque.
