# Intel<sup>®</sup> 82801E Communications I/O Controller Hub (C-ICH)

Specification Update

*January, 2002*

Order Number: 273645-002

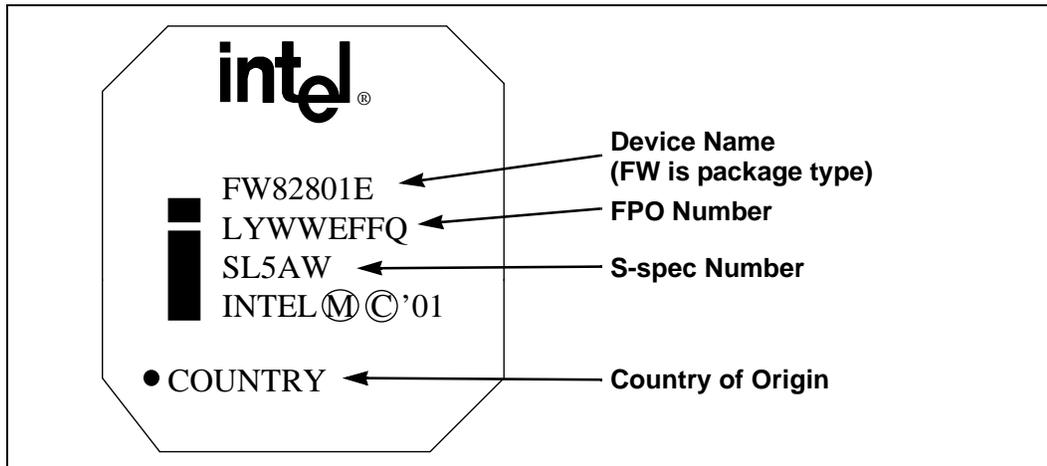
### Topside Markings

C-ICH Stepping	S-Spec	Top Marking	Notes
C-ICH A0	Q255	FW82801E Q255	Engineering Sample
C-ICH A0	SL5AW	FW82801E SL5AW	Production version
