Intel® Application Accelerator User's Manual

*Revision 2.0
May, 2002*

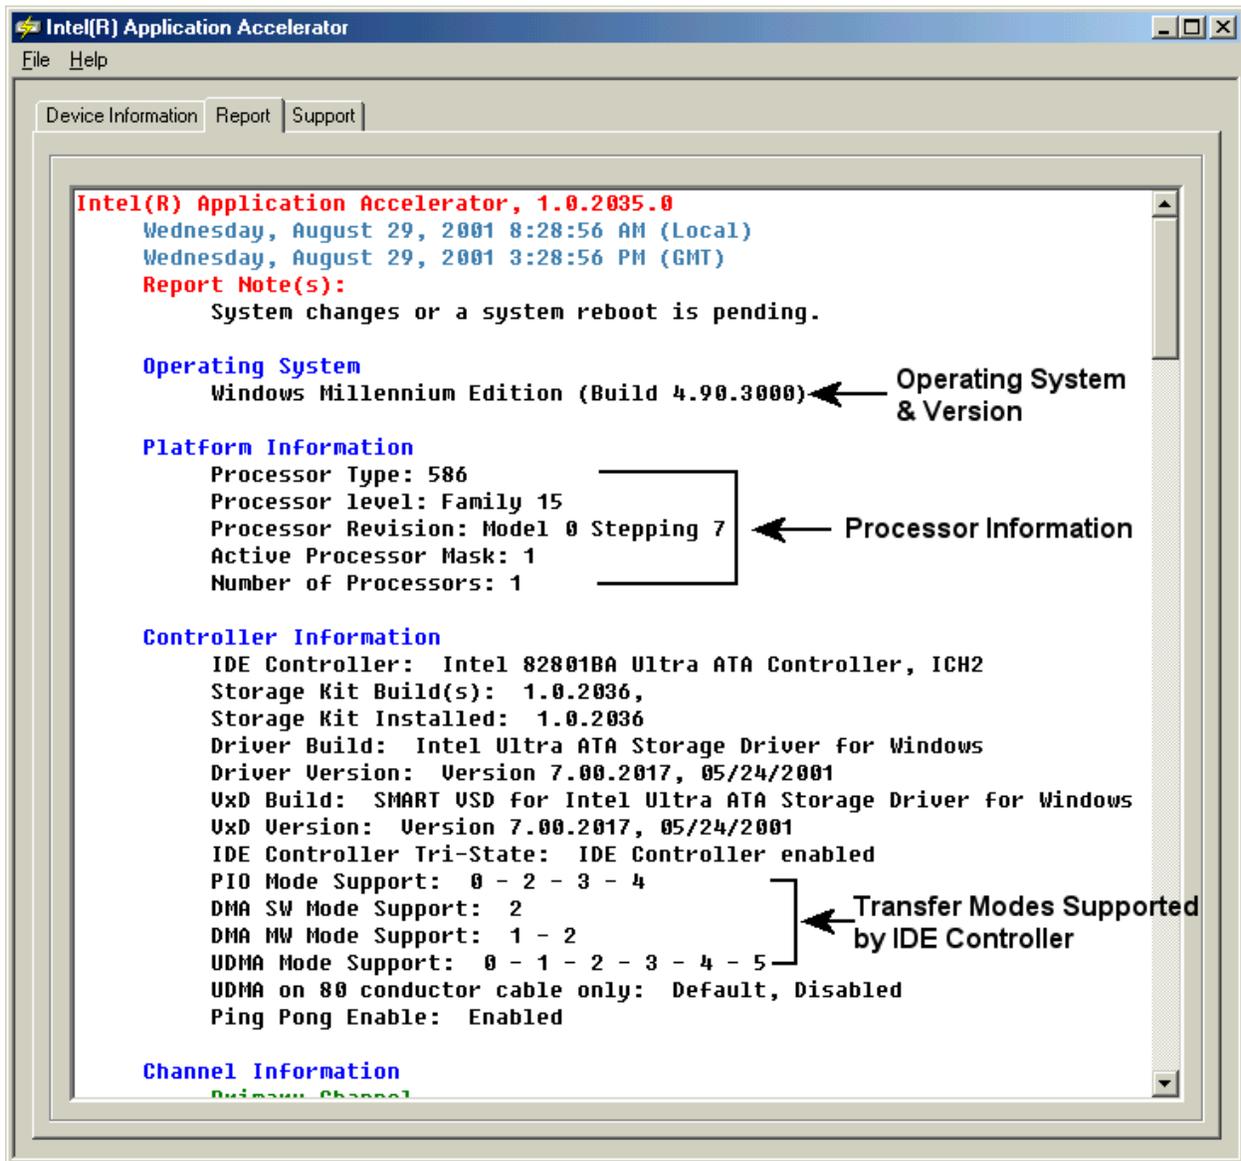
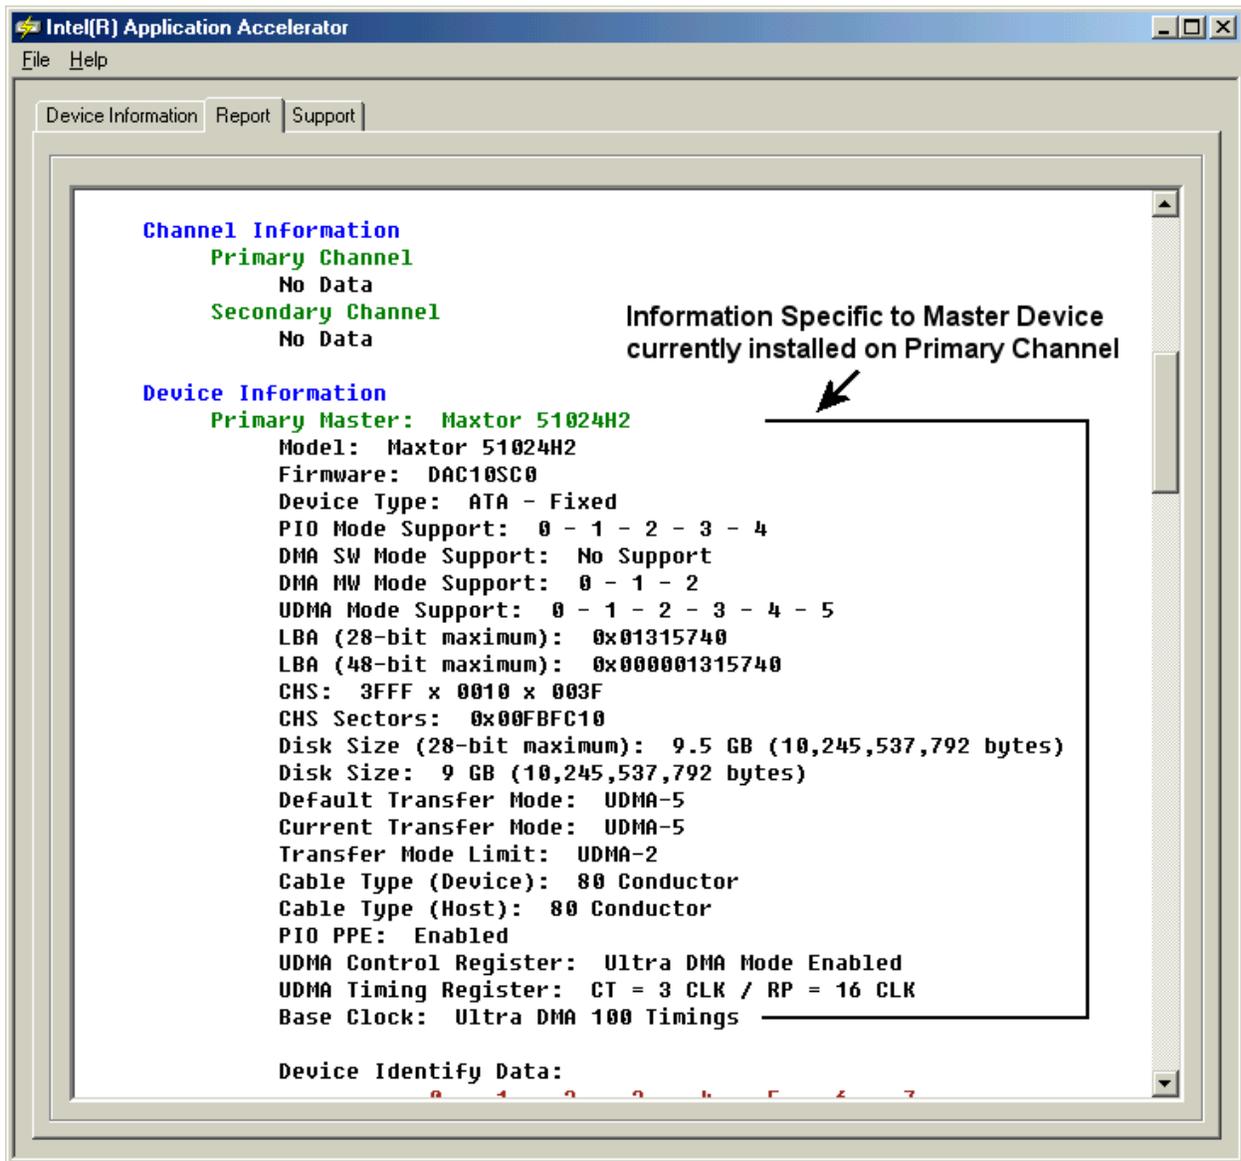
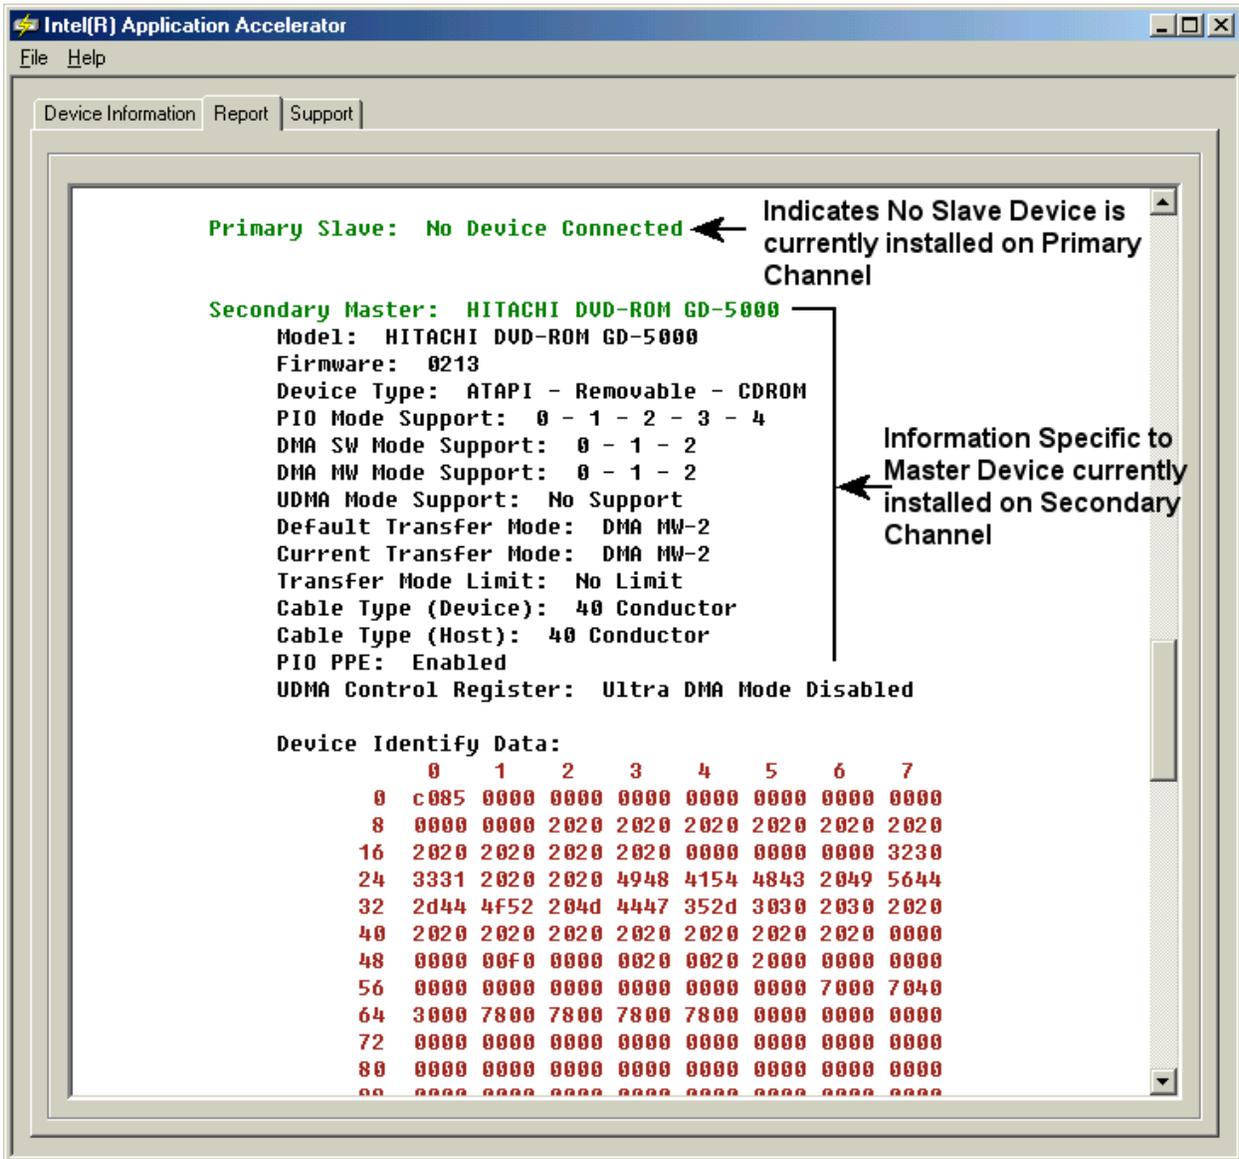
The following is an example of a generated report using the Intel Application Accelerator diagnostic utility:

Note: A generated report from your system can differ from the following example.
