Intel Server RAID Controller U2-1 Troubleshooting Guide

**A Guide for Technically Qualified
Assemblers of Intel® Identified
Subassemblies/Products**

*Revision 1.0
January 15, 2000*

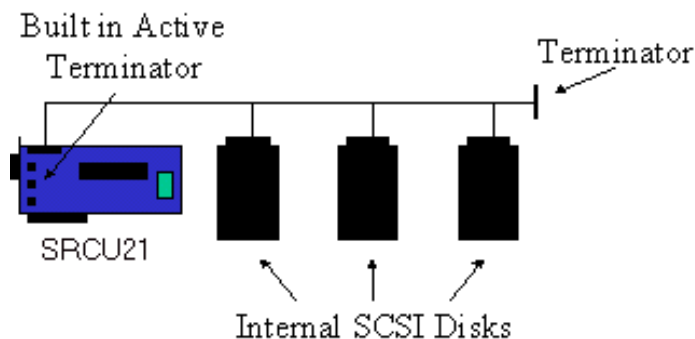
- Terminators are special electrical resistors
 - The SCSI bus must be properly terminated at both ends so that commands and data can be transmitted to and from all devices on the bus
- Active Termination
 - Detects if termination at the card is needed
- The adapter provides active termination
- With no other drives attached externally to the same channel, active terminators sense that termination needed at the card.

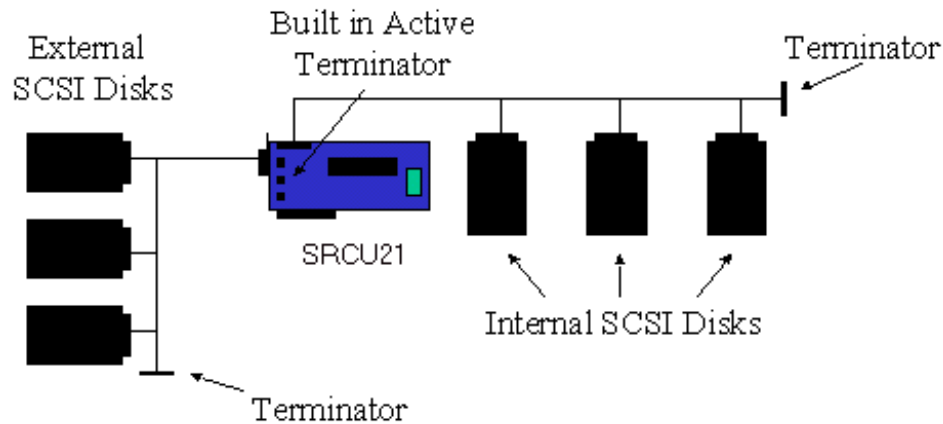
- With drives attached to one channel both internally and externally, active terminators detect that they are not needed, and the user must terminate the ends of the bus manually.
