# Intel<sup>®</sup> Server RAID Controller U2-1 (SRCU21)

Specification Update

June 2001

Order Number: 245413-016

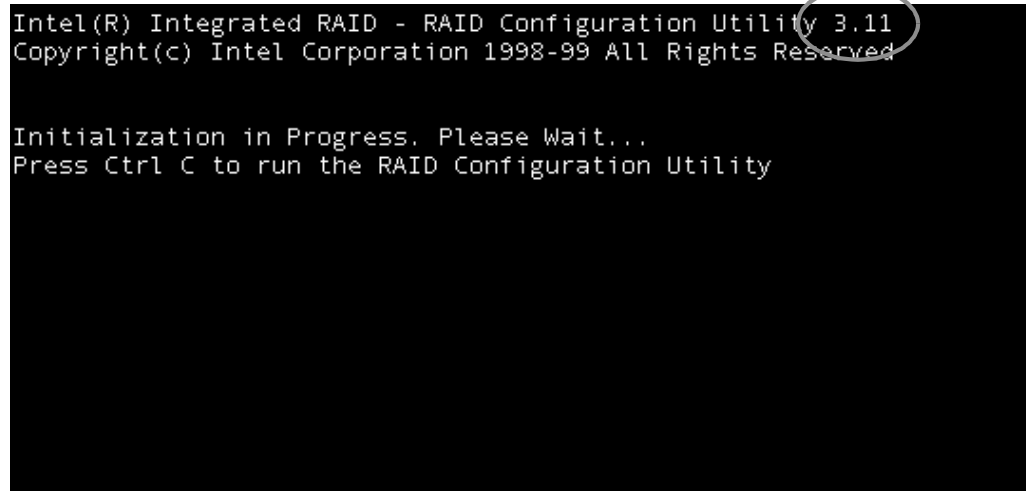
**Figure 2. RCU Version Number**

During the system boot process, the RAID Controller firmware initializes the RAID Configuration Utility. The end of the first line on the screen shown in [Figure 2](#) displays the RCU version number.

```
Intel(R) Integrated RAID - RAID Configuration Utility 3.11
Copyright(c) Intel Corporation 1998-99 All Rights Reserved

Initialization in Progress. Please Wait...
Press Ctrl C to run the RAID Configuration Utility
```

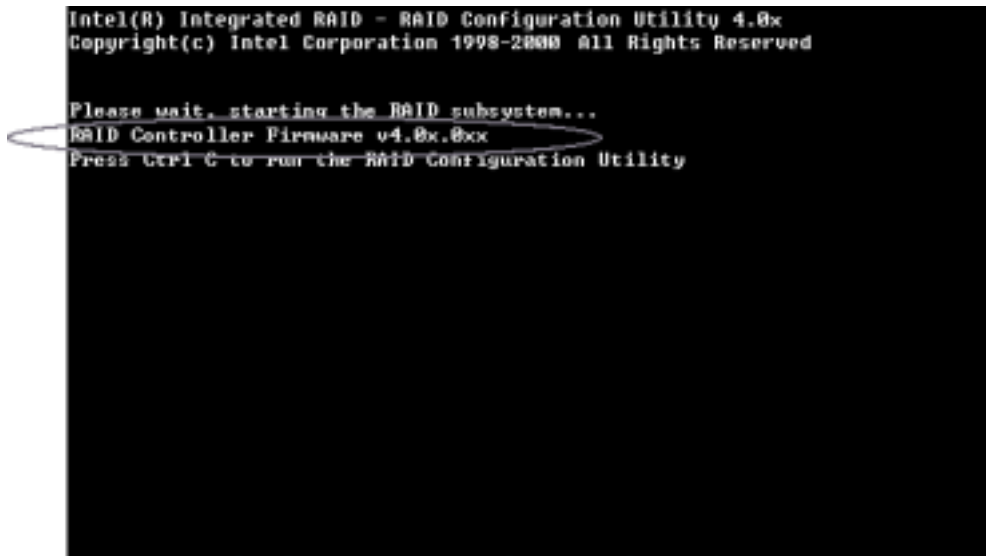
Figure 3. Firmware Version Displayed in RCU

There are two methods for identifying the firmware version installed on the RAID adapter. While the system is booting, the RAID controller firmware initializes and displays the information shown in [Figure 1](#) to the screen. The firmware version is displayed next to the words “RAID Controller Firmware”.
