Intel[®] Server RAID Controller U3-1 (SRCU31)

Specification Update

June 2001

Order Number: 273398-011

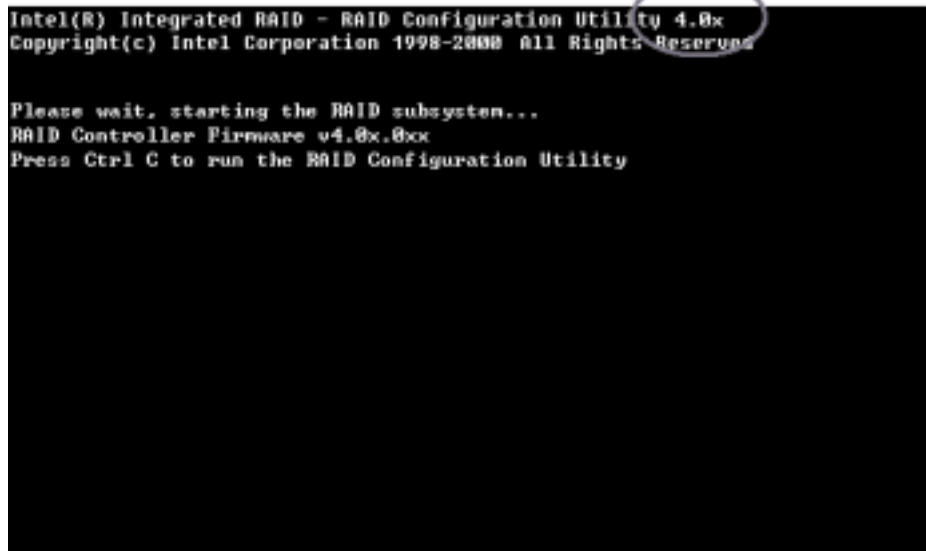
Figure 3. RCU Version

During the system boot process, the RAID Controller firmware initializes the RAID Configuration Utility. The end of the first line on the screen shown in Figure 3 displays the RCU version number.
