# Intel<sup>®</sup> Integrated RAID Controller SRCU32

Specification Update

December 2002

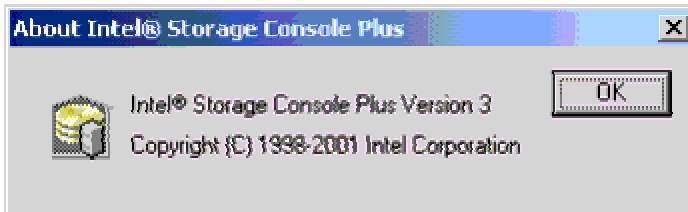
The StorCon+ version is displayed in StorCon+ About window. See [Figure 3](#).

**Figure 3. StorCon+ and Application Version Displayed in Storage Console Window**
